**Our Client: Victoria Square (Chichester Street) Residential Management Ltd
Property: Victoria Square Residential Apartments, Chichester Street, Belfast**

We are engaged to act for VS(CS)RML in connection with legal proceedings relating to the failure of a structural column passing through two of the Chichester Street apartments and wider issues of concern with the structural integrity of the building. These issues have resulted in the entirety of the Chichester Street section of the Development (including the 91x properties mentioned in the Schedule hereto) being evacuated in April 2019.

On 1 February 2019, it became apparent on inspection by VS(CS)RML that there was a partial failure of a structural column (E2) within the Chichester Street section of the Development. The structural damage was physically evident within 2x fourth floor apartments (Apartments 406 & 407).

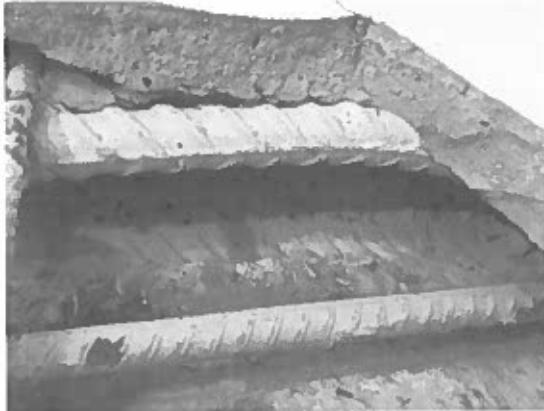
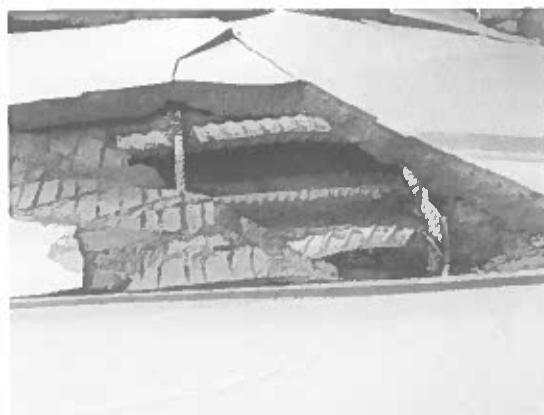
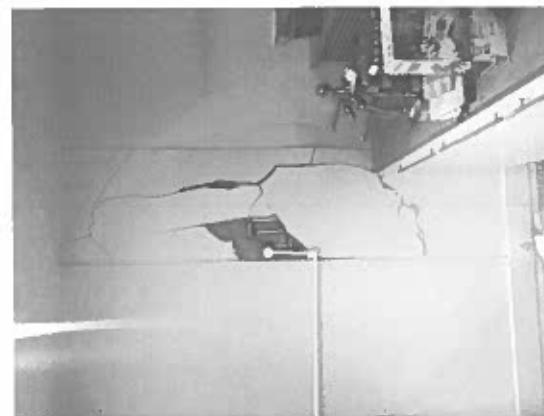
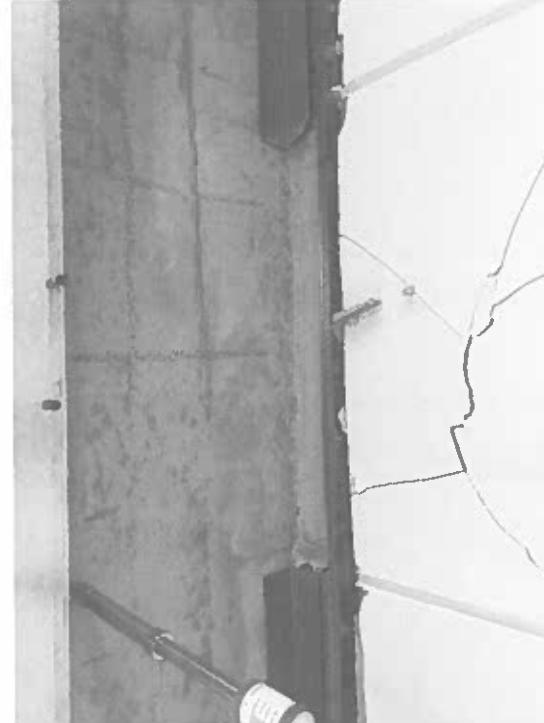
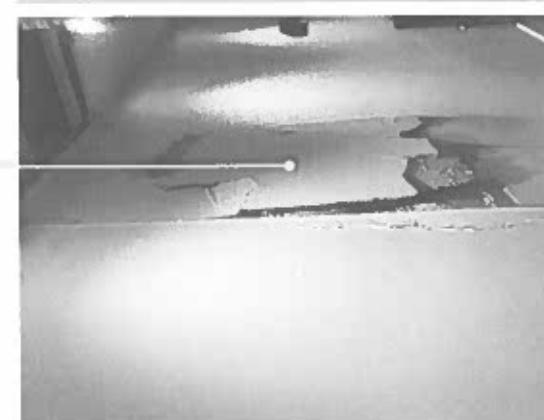
We can see the reinforcement bars within the column have bulged and deformed, by approximately 80mm laterally. There is material loss where the bars have displaced. The reinforcement bars have been painted white at some stage. It is clear that a repair has taken place on the column, we would assume prior to fit-out stage. The repair material is pink in colour, and does not appear to be a concrete repair product- this should be confirmed by sampling.

The bottom row of photographs show the damage in apartment 407. There appeared to be less damage evident on this side of the column. There were no obvious signs of repair to this side of the column.

We can reasonably assume the reinforced concrete column has partially failed at this level due to the historic repair work.

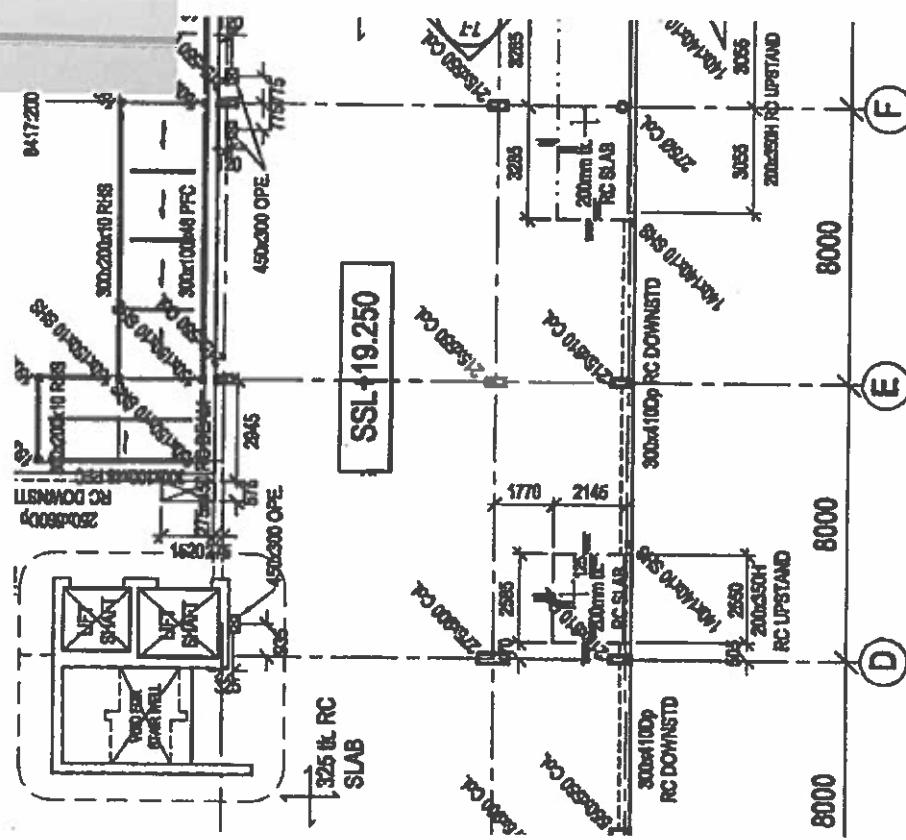
RESIDENTIAL LEVEL 05

Apartment 506 was not available to view. We viewed apartment 507. Distress can be seen in the adjacent photographs - cracking in the plasterwork at column E2. Further cracks were noted where the dividing blockwork wall meets column E1. We would assume these cracks have appeared due to movement caused by the partial failure of the column at level 04, coupled with some downward displacement.

We would advise that a level survey takes place on the level 05 slab in this area to determine how much the slab has deflected due to the partial failure in the column at level 04.

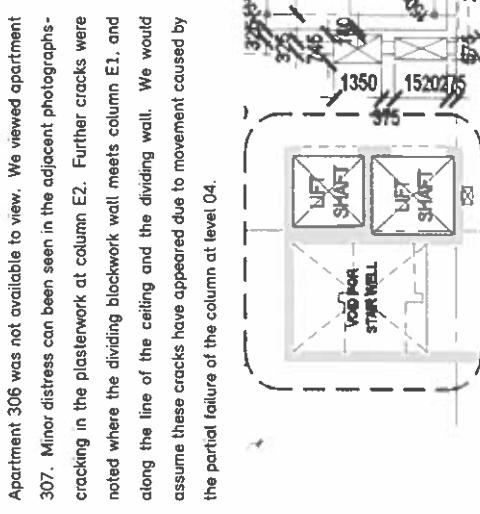
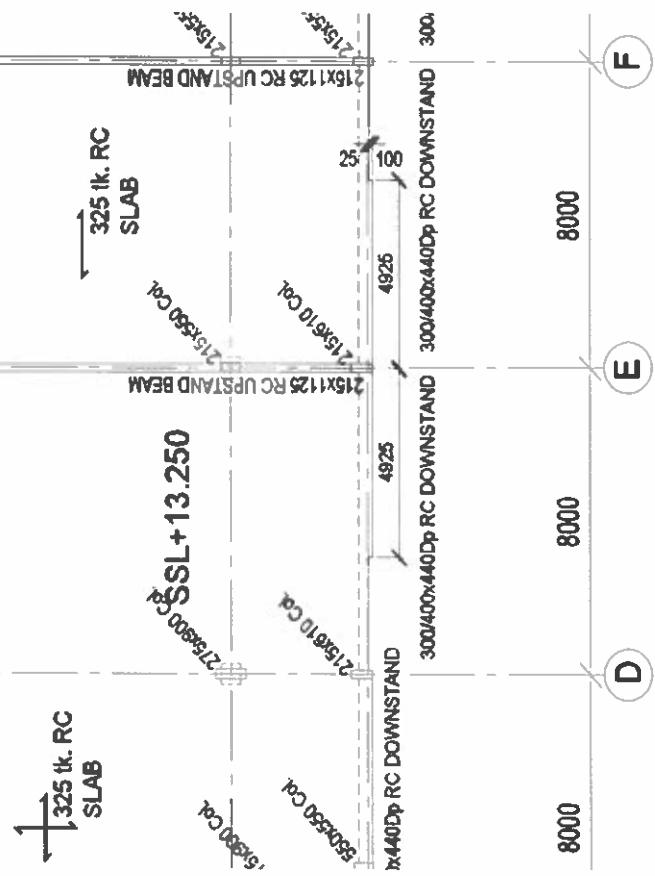
RESIDENTIAL LEVEL 03

Apartment 306 was not available to view. We viewed apartment 307. Minor distress can been seen in the adjacent photographs - cracking in the plasterwork at column E2. Further cracks were noted where the dividing blockwork wall meets column E1, and along the line of the ceiling and the dividing wall. We would assume these cracks have appeared due to movement caused by the partial failure of the column at level 04.

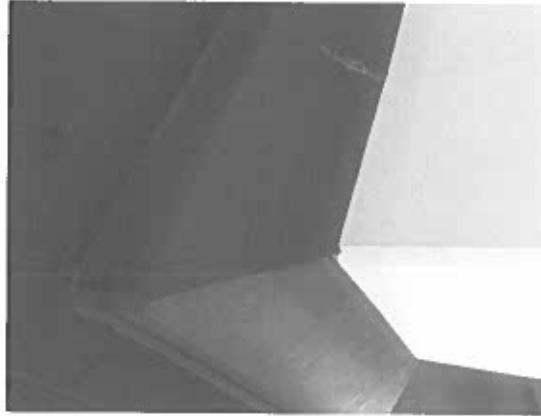
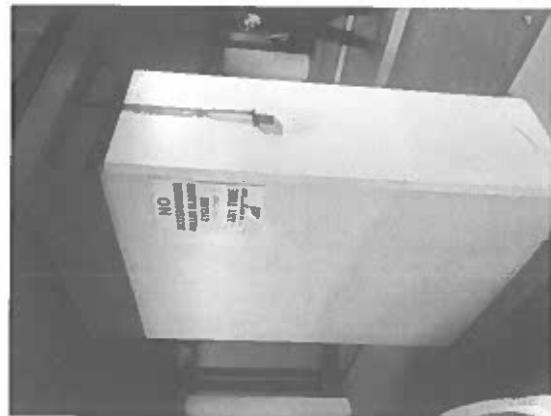
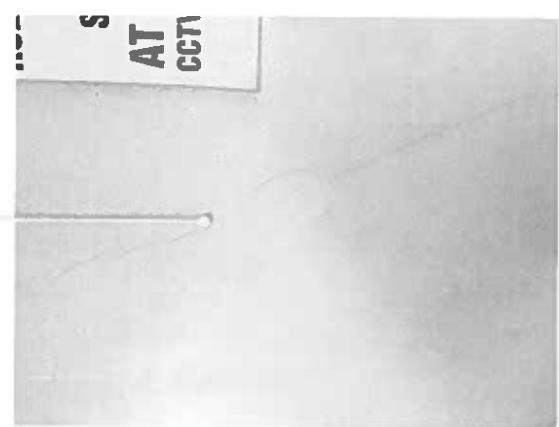
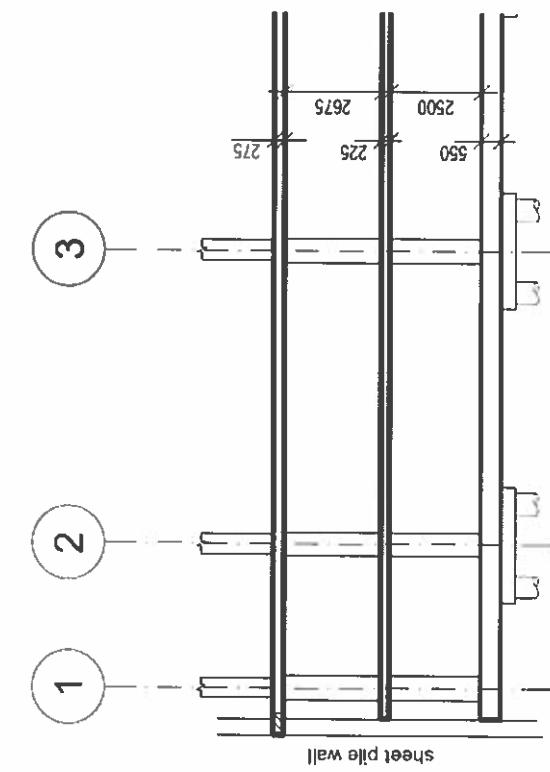
BASEMENT LEVELS

The top row photograph shows the flared column head at level B1. The column measured as a 150mm x 700mm concrete column. No significant cracks were present in column E2 at B1 level.

The bottom row of photographs show column E2 at B2 level. Cracking can be seen in the adjacent photographs. This seemed to be common in a few of the columns observed in this basement area, therefore we can assume it is not connected with the issue at level 04.

We also carried out a review of the load acting on the B2 column, and calculated the column capacity based on limited record information and reasonable assumptions. The column does not appear to be over stressed for the intended design load at this location.

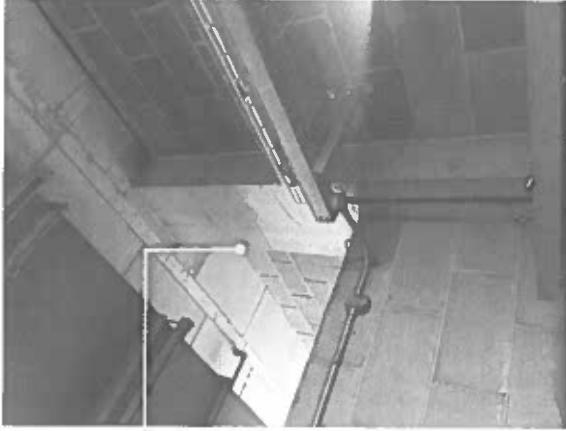
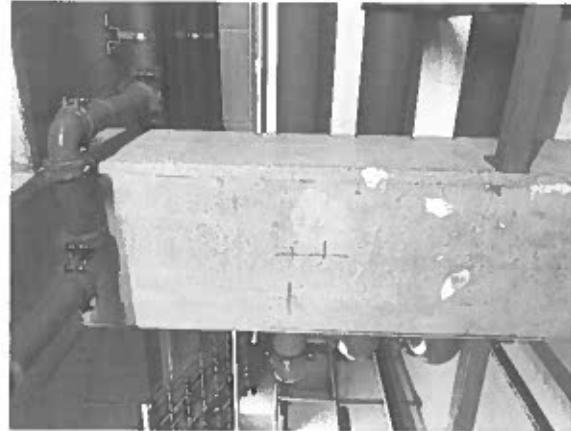
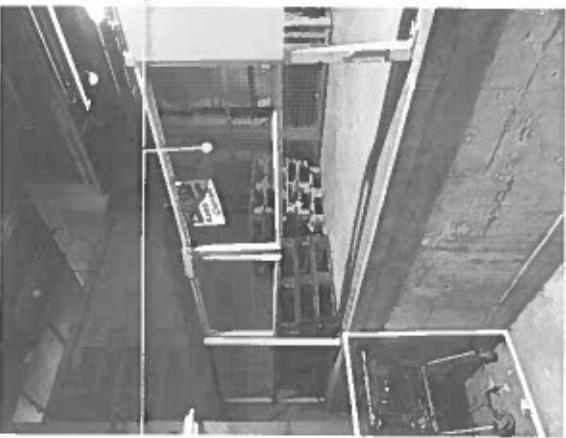
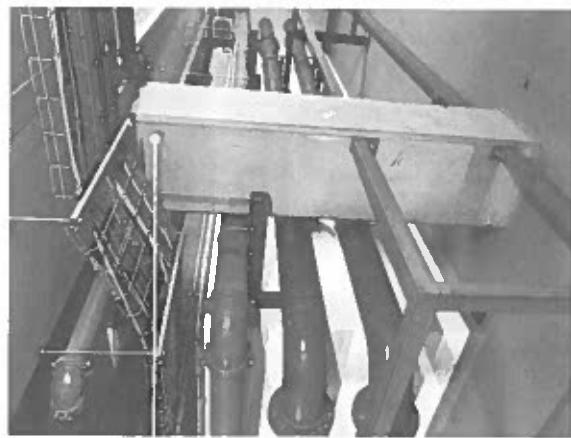
GROUND & LOWER GROUND LEVEL

Column E2 was viewed in both the Service Yard and the Bin Store at ground level. The column was measured, 550mm x 550 mm square. No obvious defects were noted here. The top photographs show the column in the Service Yard.

The bottom row of photographs shows column E2 at the lower ground level. This is in a service run at the back of the retail units. The column was measured, 550mm x 550 mm square. No obvious defects were noted here. The density of services in pipework in this area will need to be considered for the propping design and installation. Some of these services may need to be re-routed or removed temporarily. From record information the lower ground floor slab appears to be a 275mm deep post tensioned slab.
