## REPORT TO THE COMMISSIONER OF VALUATION

Apartment 309  
70 Chichester Street  
Belfast  
BT1 4JQ

Apartment (3<sup>rd</sup> floor)

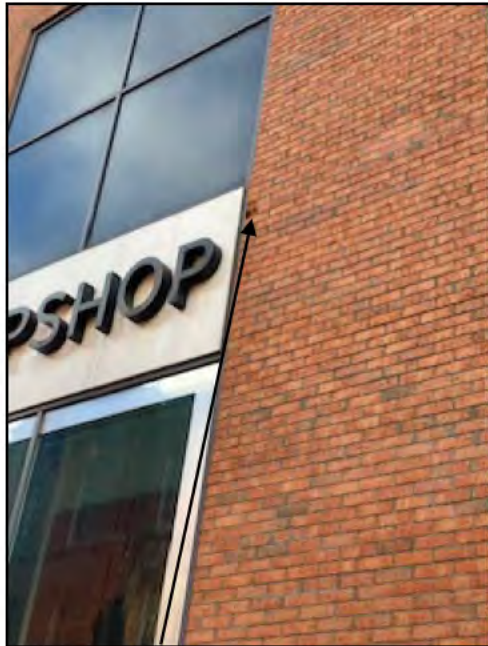
**Reports of spalling brickwork**

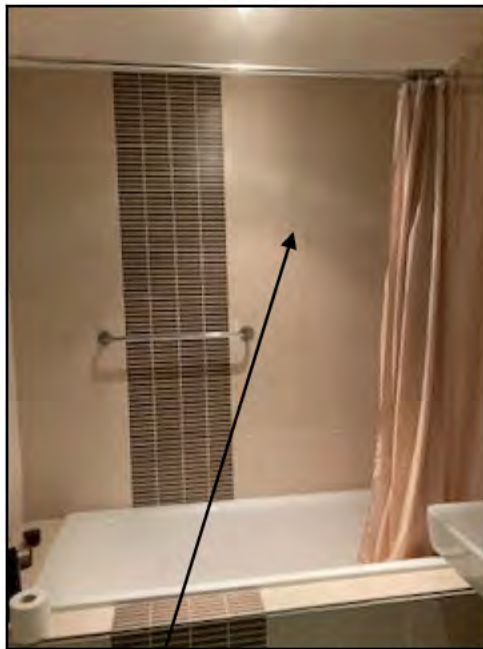
**Bathroom – visible cracks to tiling**

I was able to inspect the subject on 01/10/21 accompanied by [REDACTED] from the Management Company. No obvious defects were noted bar some hairline cracks to the bathroom tiling and top corner of one of the bedrooms. Photographs can be seen on pages 5-8. [REDACTED] pointed out spalled bricks externally and indicated this could be a sign of further structural defects.

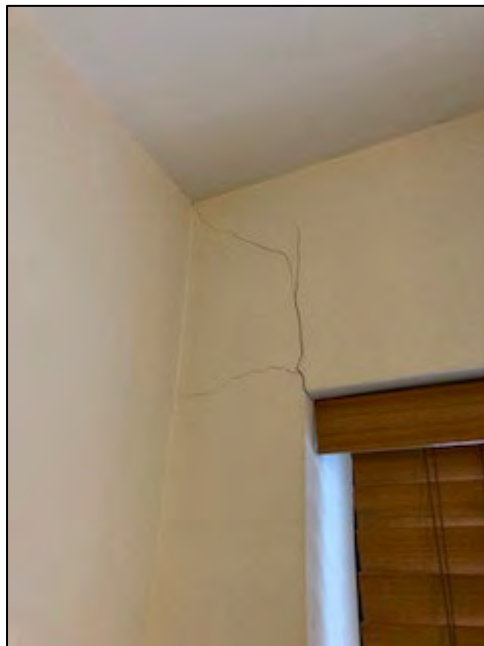
**Bedroom 2 – visible signs of cracking**

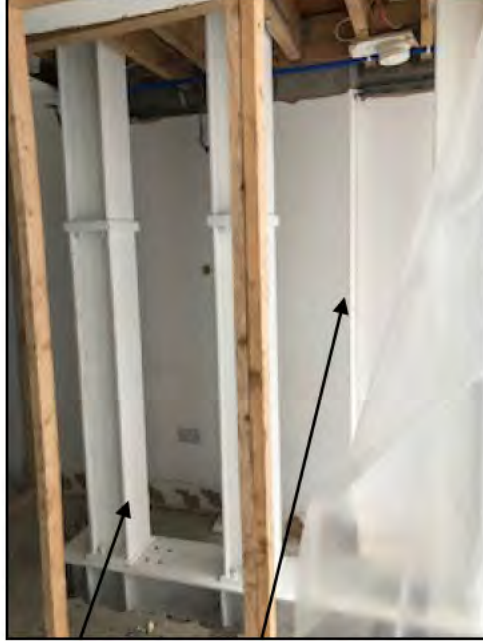
**Props & failed steel column**

The appeal is in connection to partial failure of column E2 in apartments 406 & 407 on the fourth floor of the apartment development. Temporary props (steel columns) were installed in 2019 to support the defective column until repairs could be carried out. This propping has been carried out down to basement level.

We first inspected the 1<sup>st</sup> & 2<sup>nd</sup> floor multi-level apartment 202. As illustrated in the photographs on pages 10-12 I could see the props (steel support columns) that have been installed either side of the failed steel column. These props have 'strain sensors' attached, which are measuring the load the 'props' are taking. The data recorded by the sensors is being monitored remotely. The solicitor advises that the apartments that these are in (approx. 17) cannot be occupied as the vibration would be picked up by the 'strain sensors' resulting in inaccurate readings.

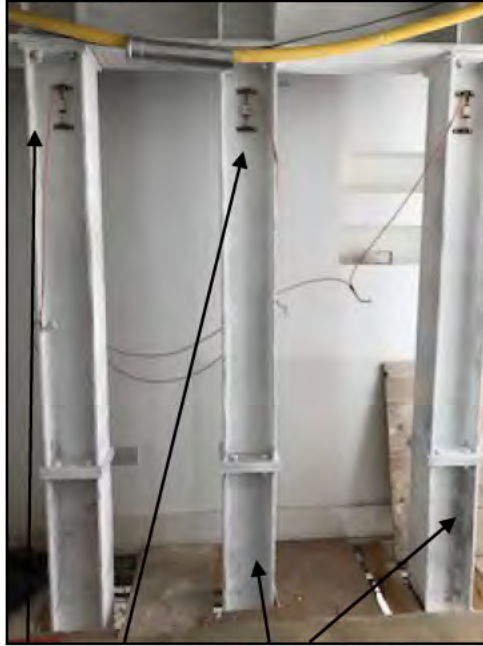
**Strain sensors: attached to props (steel support columns)**

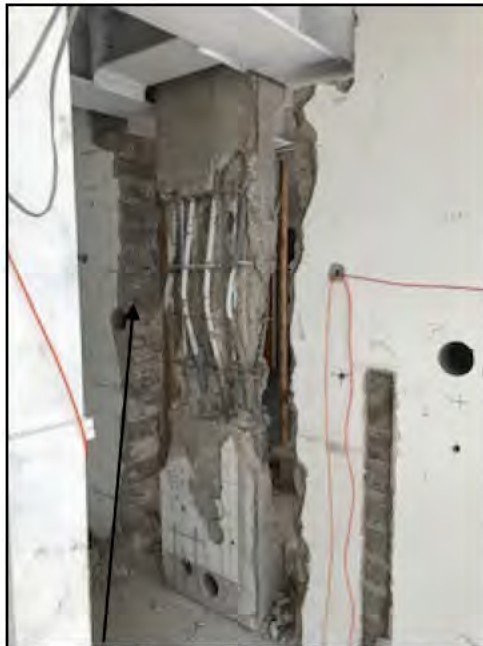
**Apartment 406 (PID 960576)**  
**Single Level Self Contained 4<sup>th</sup> floor apartment:**  
**Inspected 28/09/21**

**Reinforcement bars in column bulged & deformed**

The nature of the damage was more evident in Apartment 406. The exposed reinforced bars were clearly bulging out of the partially failed E2 structural column (see report pages 14-19 above for photographs).

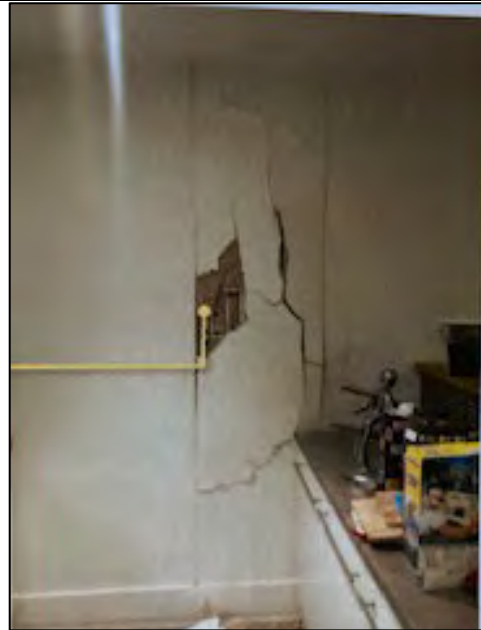
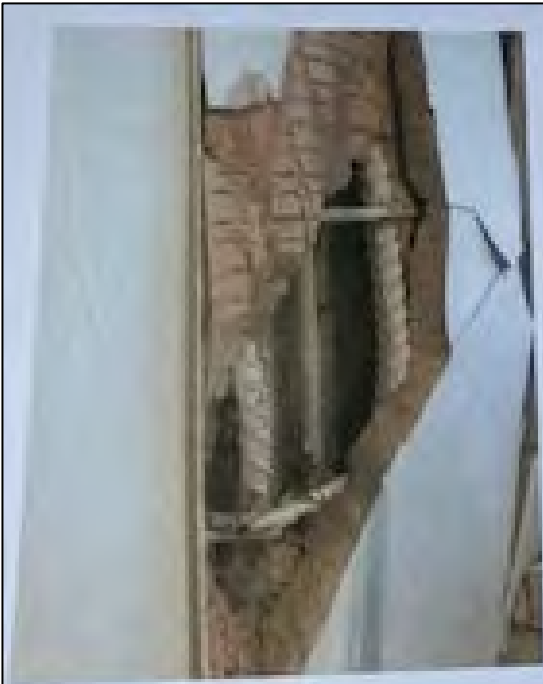
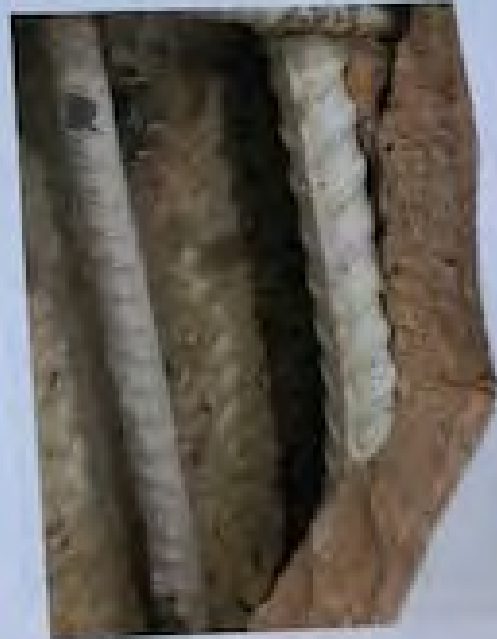
#### Apartments 406 & 407

Column E2 is located in the dividing wall between apartment 406 & 407. The top row of photographs show the distress of the column at this level.

We can see the reinforcement bars within the column have bulged and deformed, by approximately 80mm laterally. There is material loss where the bars have displaced. The reinforcement bars have been painted white at some stage. It is clear that a repair has taken place on the column, we would assume prior to fit-out stage. The repair material is pink in colour, and does not appear to be a concrete repair product - this should be confirmed by sampling.

The bottom row of photographs show the damage in apartment 407. There appeared to be less damage evident on this side of the column. There were no obvious signs of repair to this side of the column.

We can reasonably assume the reinforced concrete column has partially failed at this level due to the historic repair work.

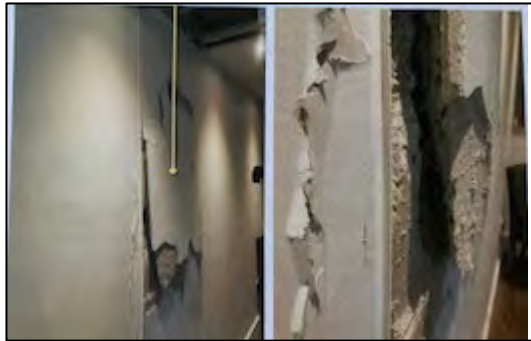
#### Apartment 507

Apartment 506 was not available to view. We viewed apartment 507. Distress can be seen in the adjacent photographs - cracking in the plasterwork at column E2. Further cracks were noted where the dividing blockwork wall meets column E1. We would assume these cracks have appeared due to movement caused by the partial failure of the column at level 04, coupled with some downward displacement.

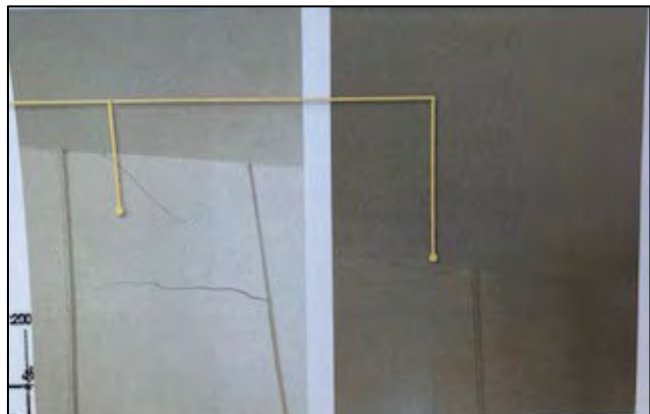
## Apartment 307

Apartment 306 was not available to view. We viewed apartment 307. Minor distress can be seen in the adjacent photographs - cracking in the plasterwork at column E2. Further cracks were noted where the dividing blockwork wall meets column E2 and along the line of the ceiling and the dividing wall. We would assume these cracks have appeared due to movement caused by the partial failure of the column of level 04.

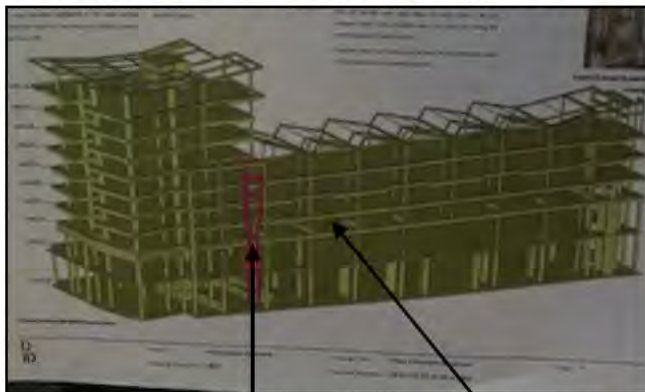
**This shows the highlighted propping around column E2 & location of subject apartment**

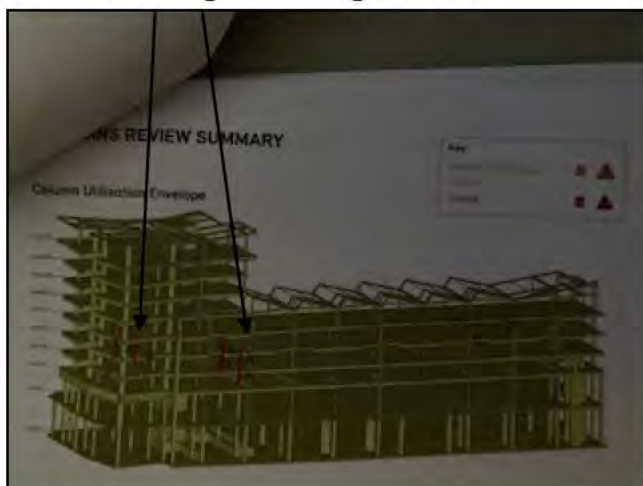
3D model showing the highlighted columns, which are above 95% utilisation under the original design load:

The report states that it is believed that column E2 partially failed due to apparent repair work with a non-structural product.
