**Our Client: Victoria Square (Chichester Street) Residential Management Ltd
Property: Victoria Square Residential Apartments, Chichester Street, Belfast**

We are engaged to act for VS(CS)RML in connection with legal proceedings relating to the failure of a structural column passing through two of the Chichester Street apartments and wider issues of concern with the structural integrity of the building. These issues have resulted in the entirety of the Chichester Street section of the Development (including the 91x properties mentioned in the Schedule hereto) being evacuated in April 2019.

On 1 February 2019, it became apparent on inspection by VS(CS)RML that there was a partial failure of a structural column (E2) within the Chichester Street section of the Development. The structural damage was physically evident within 2x fourth floor apartments (Apartments 406 & 407).

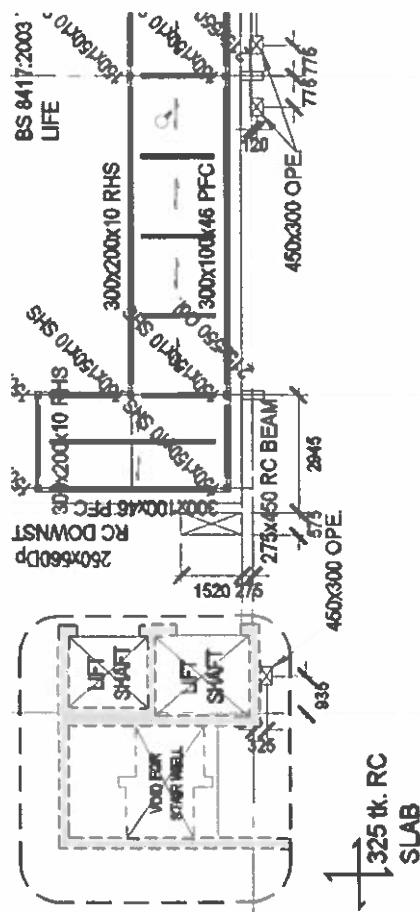
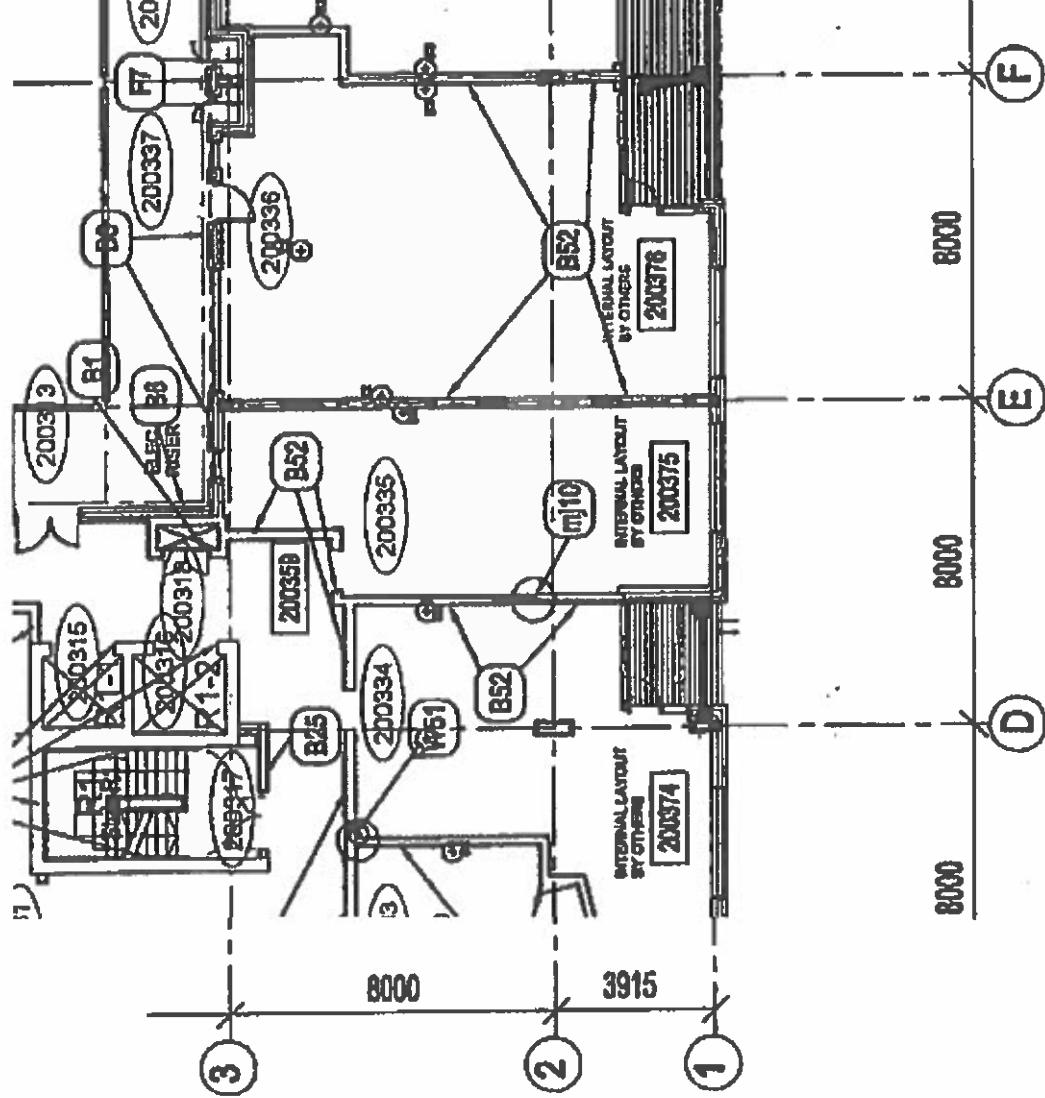
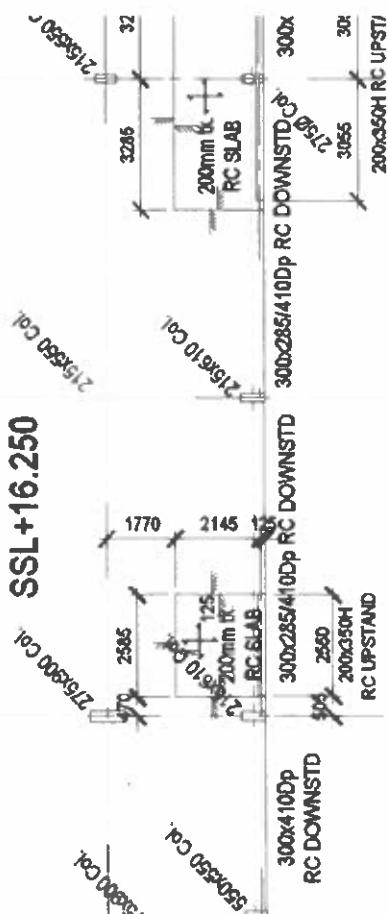
RESIDENTIAL LEVEL 04

Column E2 highlighted on both the structural and architectural drawings available below. Apartment 406 is between gridlines D & E, apartment 407 is between gridlines E & F. The structural drawing denotes the column as 215mm x 550mm, this dimension was confirmed on site.

We can see the reinforcement bars within the column have bulged and deformed, by approximately 80mm laterally. There is material loss where the bars have displaced. The reinforcement bars have been painted white at some stage. It is clear that a repair has taken place on the column, we would assume prior to fit-out stage. The repair material is pink in colour, and does not appear to be a concrete repair product- this should be confirmed by sampling.

The bottom row of photographs show the damage in apartment 407. There appeared to be less damage evident on this side of the column. There were no obvious signs of repair to this side of the column.

We can reasonably assume the reinforced concrete column has partially failed at this level due to the historic repair work.

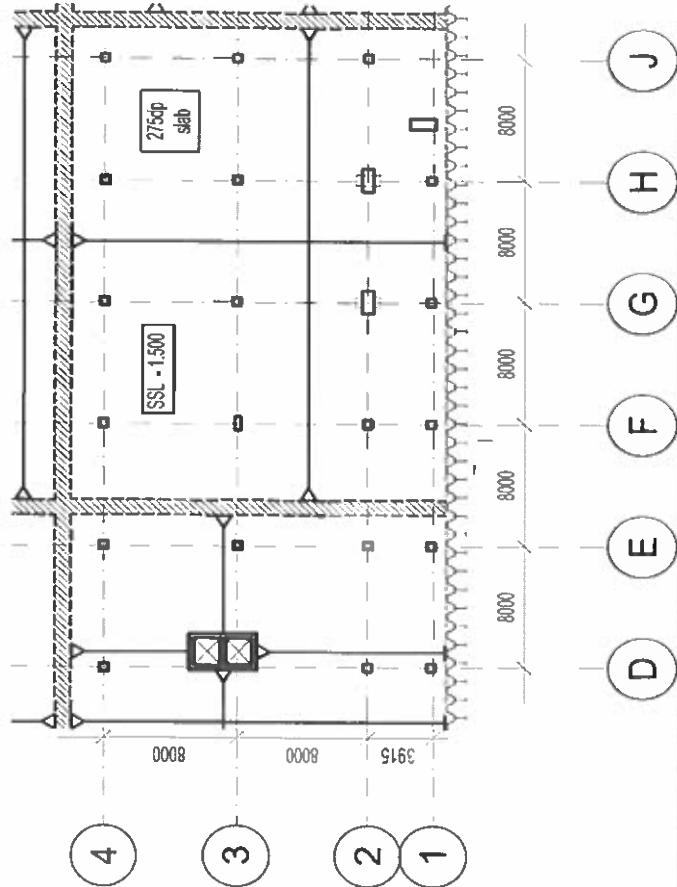
Column E2 was viewed in both the Service Yard and the Bin Store at ground level. The column was measured, 550mm x 550 mm square. No obvious defects were noted here. The top photographs show the column in the Service Yard.

Ground level slab is noted as a 350mm thick two way spanning reinforced concrete slab on Building Control structural drawings.

The bottom row of photographs shows column E2 at the lower ground level. This is in a service run at the back of the retail units. The column was measured, 550mm x 550 mm square. No obvious defects were noted here. The density of services in pipework in this area will need to be considered for the propping design and installation. Some of these services may need to be re-routed or removed temporarily. From record information the lower ground floor slab appears to be a 275mm deep post tensioned slab.

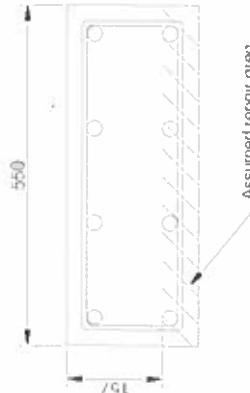
LOAD TO BE PROPPED

The load capacity of the reduced column cross section was based on an area of concrete behind the bars that have deflected (157mm x 550mm), further investigation could determine remaining concrete cross section.

The reduced cross section has approximately 20-30% less load carrying capacity than the 215mm x 550mm cross section, which is therefore a theoretical design failure.

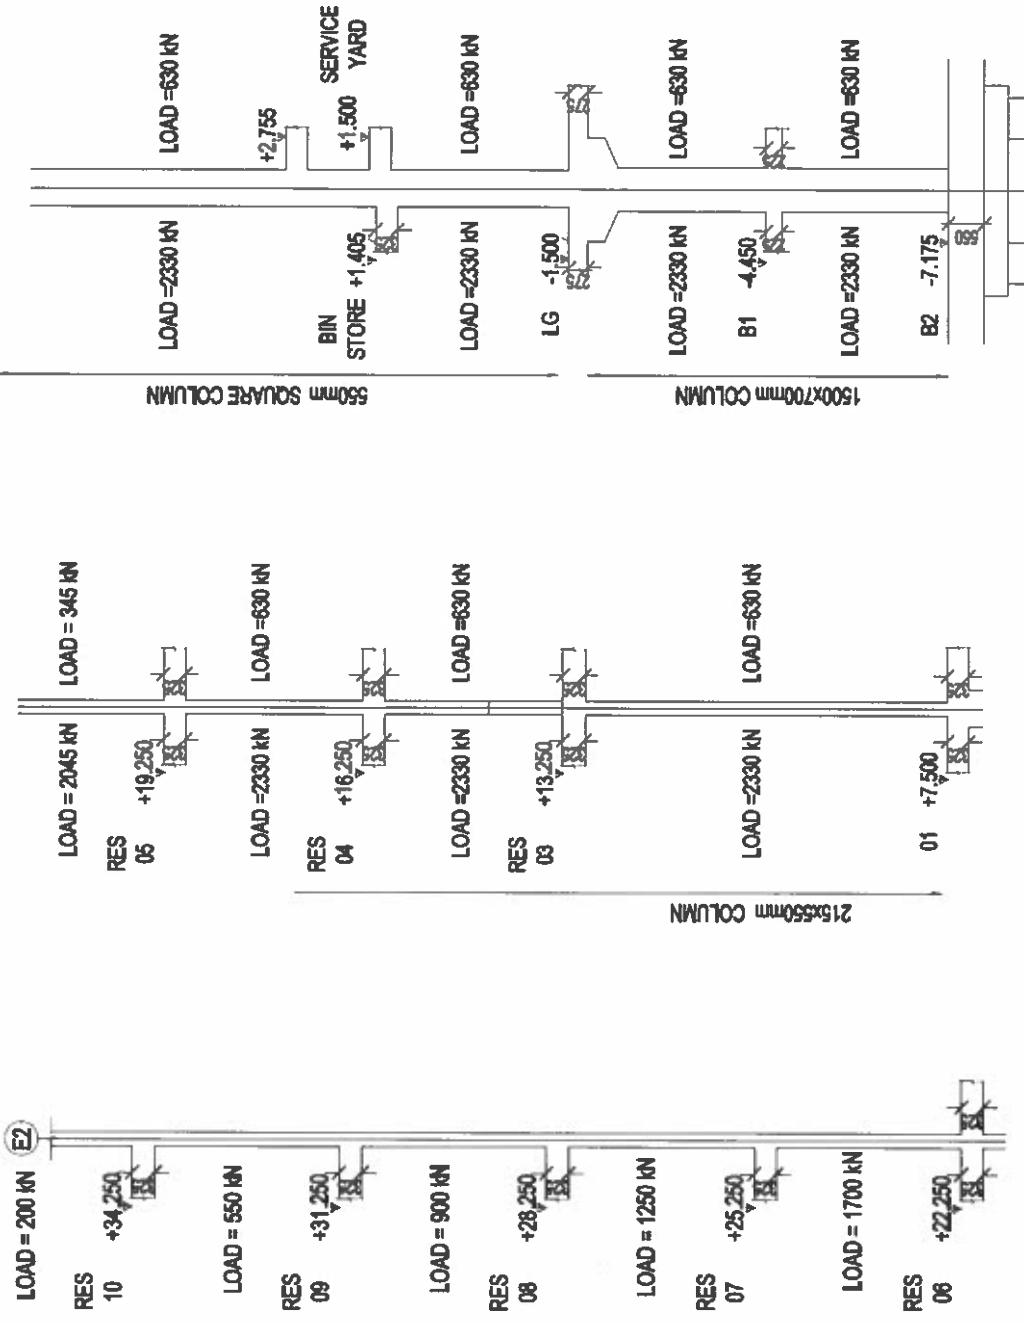
Load Takedown

The loads were extracted from the 3D finite analysis model for column E2 and are noted adjacent. From this we can see the total load to be propped at level 04 is 2960 kN. The propping will carry through to basement level.

**ALL LOADS NOTED ARE UNFACTORED
(DEAD LOAD = 75%, IMPOSED LOAD = 25%)**

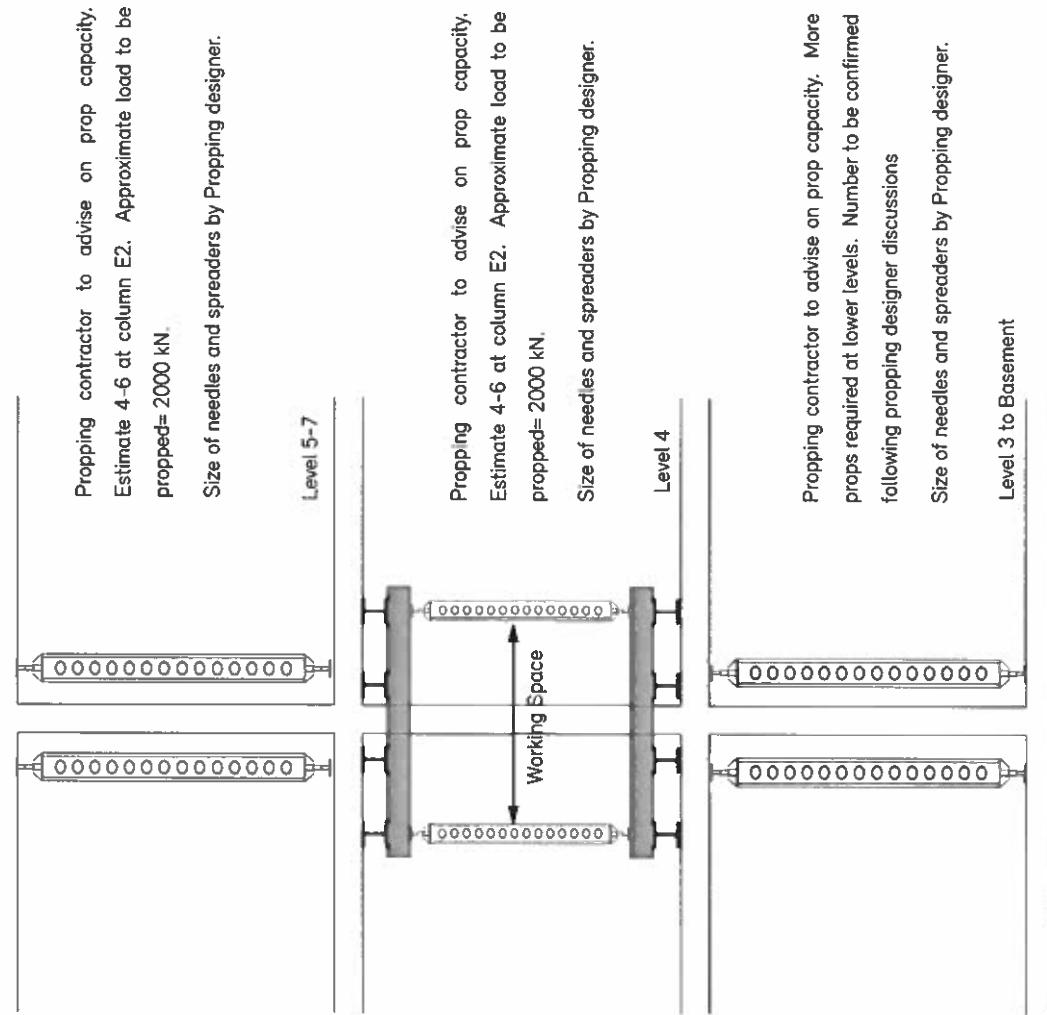
INITIAL PROPPING CONCEPT

We issued the sketch, 13th February 2019, alongside to the propping designer to give them an idea of the form and extent of propping required. This has been developed further following a review of historical information supplied at a later date. Extent and loading has since been updated.

Propping contractor to advise on prop capacity.
Estimate 4-6 at column E2. Approximate load to be
propped= 2000 kN.

Size of needles and spreaders by Propping designer.

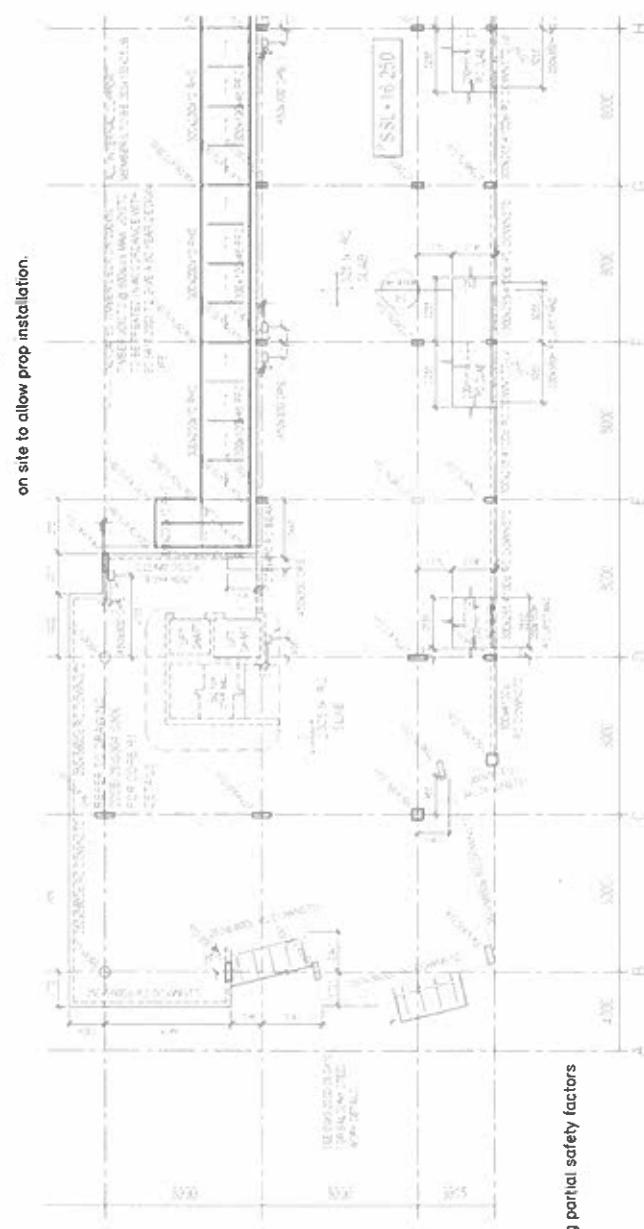
Plan extract from record drawings highlighting column E2 location

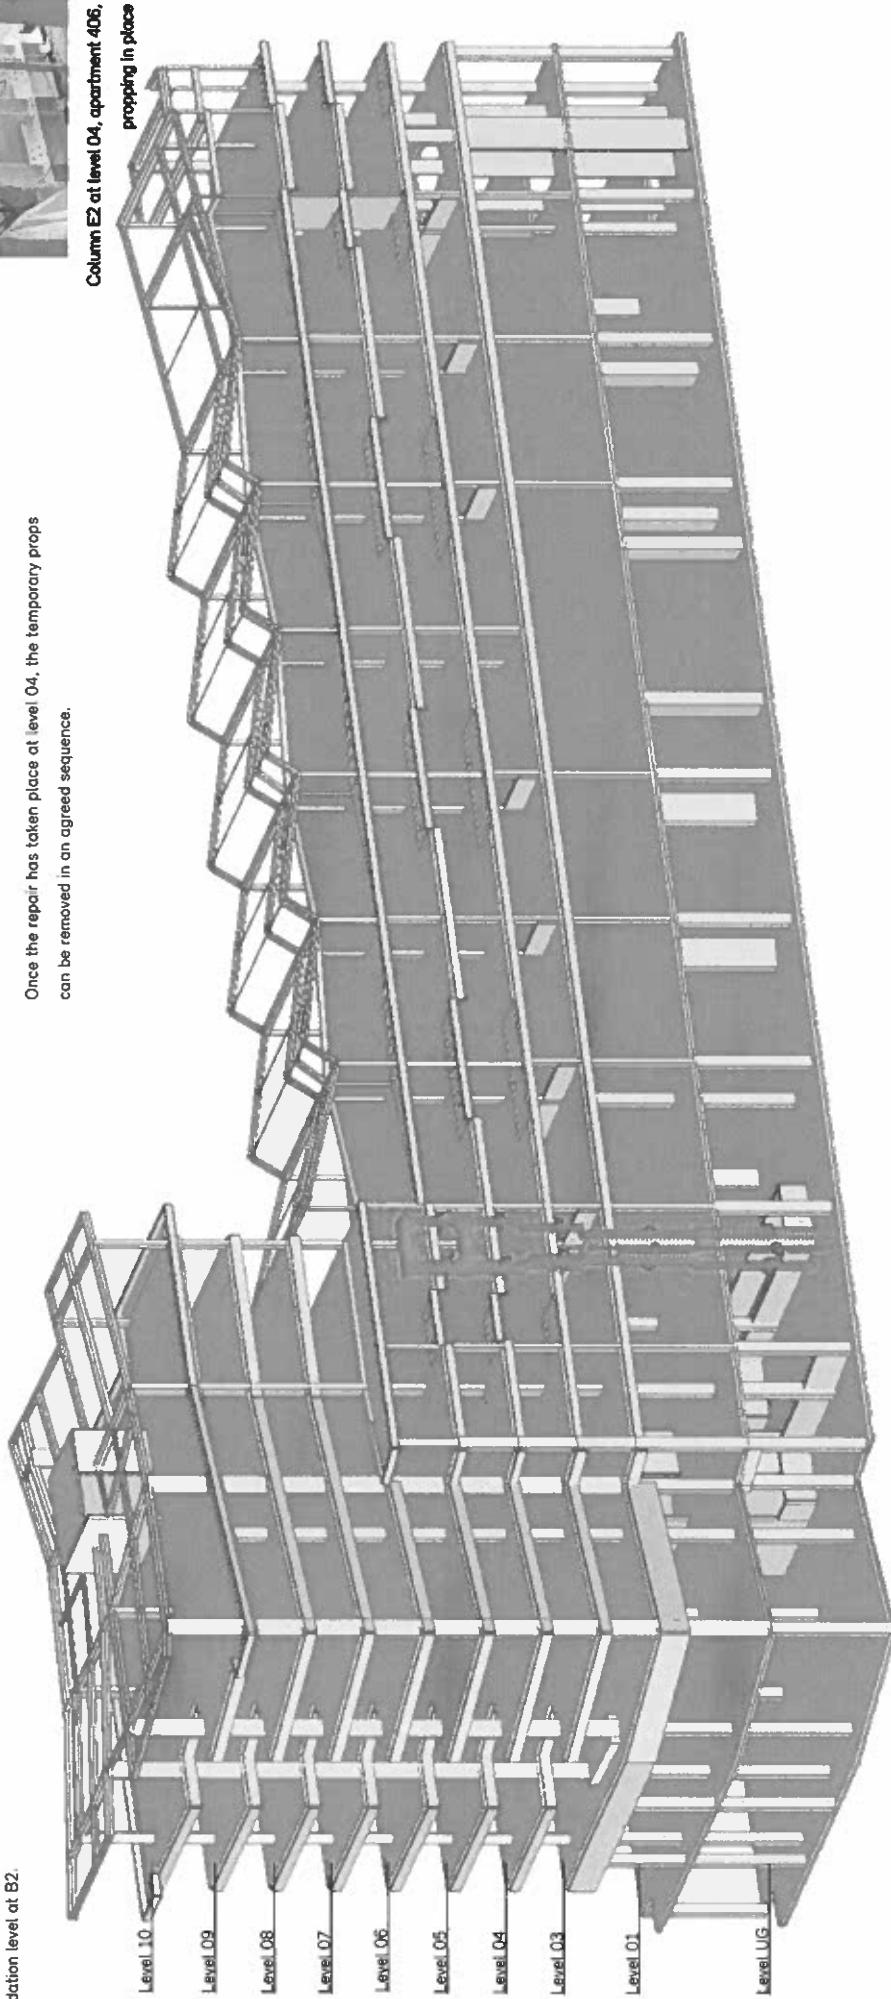
Previous to the instruction of this report, we were appointed to design the temporary propping. Propping around column E2 has been installed, and will remain in place until column C18/05 is repaired. The temporary props, comprising of Universal Column structural steel sections, have been modelled. The ground floor to level 05 props have been highlighted in the model extract below. It should be noted that the temporary propping extends to foundation level at B2.

The props have been designed and installed to allow for working space around column E2 level 04 [C18/05] to enable the column repair works to be carried out. The detail drawings for the propping arrangement at each floor level can be found in the appendix of this report. The props are installed touch tight, and grouted in place.

3D model showing highlighted temporary props

Once the repair has taken place at level 04, the temporary props can be removed in an agreed sequence.

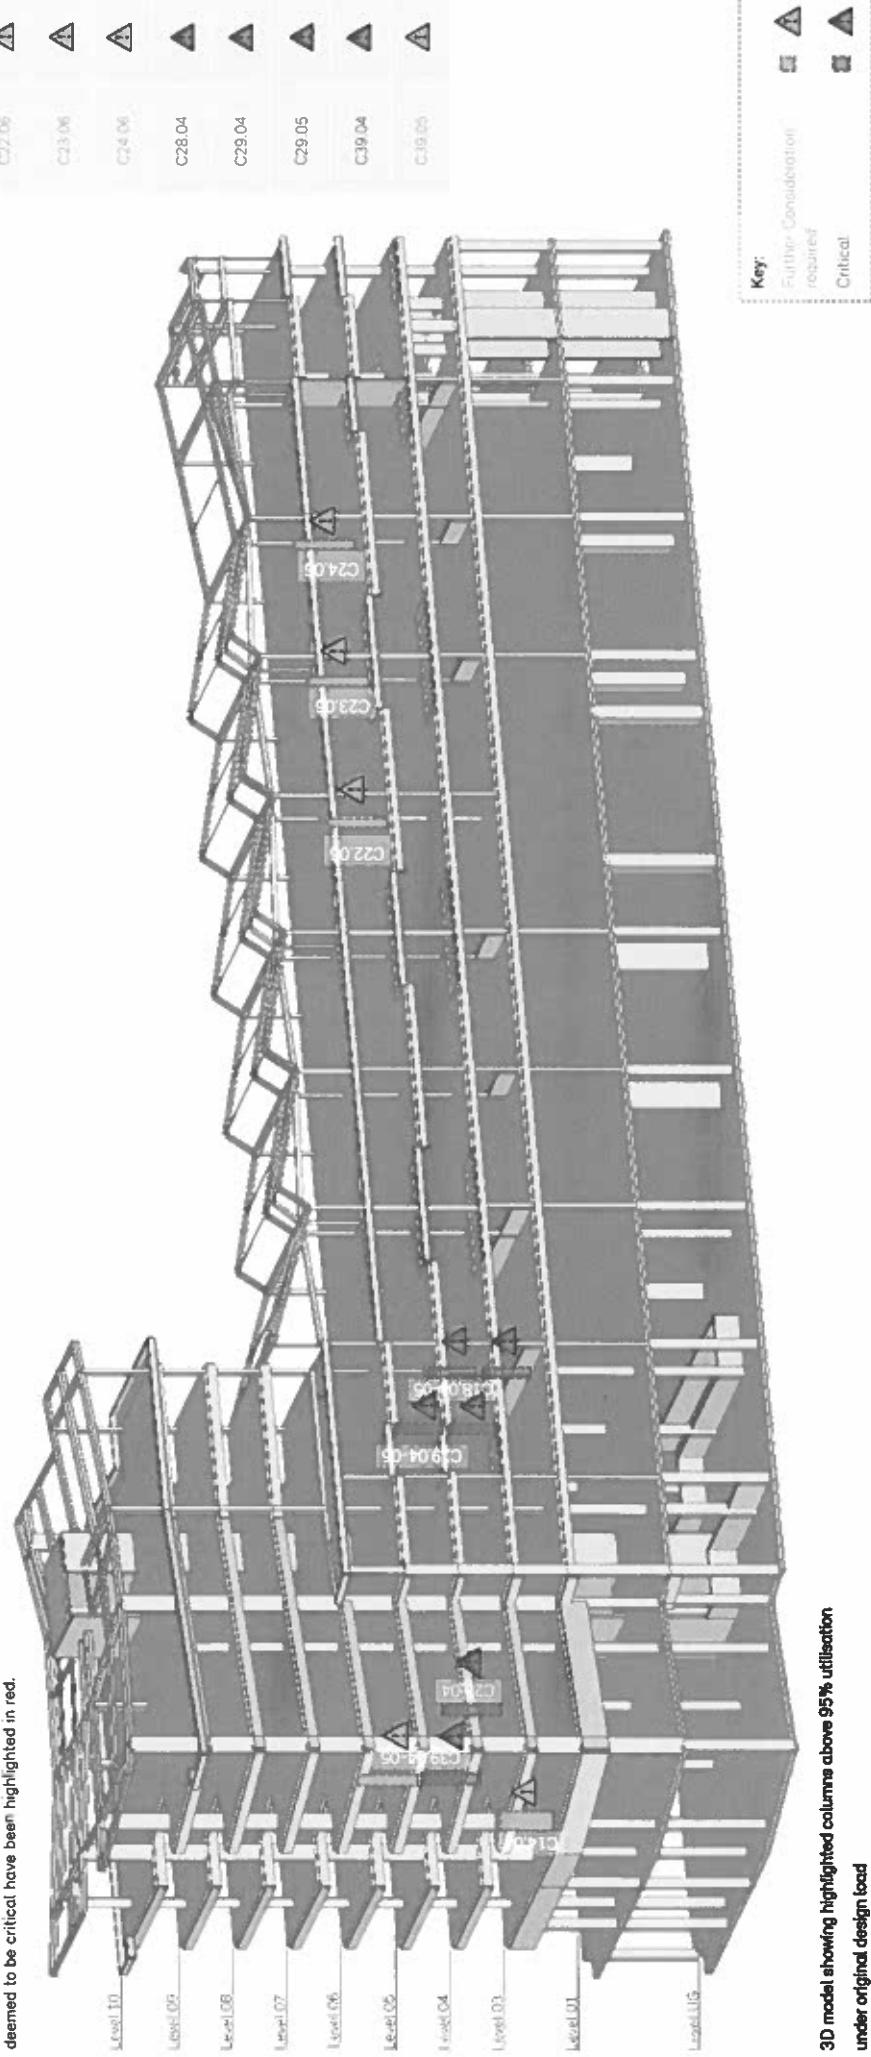
It should be noted that the column that partially failed, E2 at level 04, identified as column C18.05, is quite considerably over capacity at both level 03 and 04 and therefore critical, as discussed in Page 13.

Columns shown in magenta in the 3D below are approaching 95% utilisation. Their percentage utilisation can be seen in the following slide.

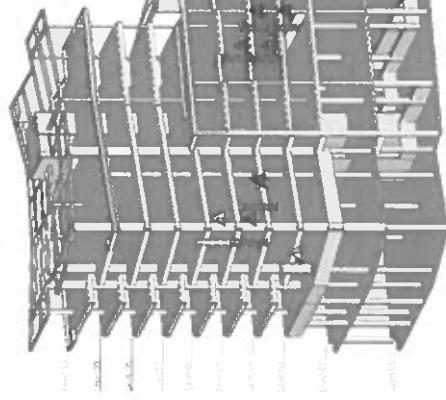
3D model showing highlighted columns above 95% utilisation under original design load

Column sections found exceeding 95% utilisation during initial checks have been highlighted in amber colour in the adjacent table and noted for further review. Columns which have been deemed to be over-utilised and therefore 'critical' have been highlighted in red. It is recommended that these columns be considered for propping and remedial works immediately.

Columns which have been denoted as requiring further consideration have been found to be greater than 95% utilisation according to Method 1 calculations but not necessarily over capacity according to further Method 3 (MasterSeries) calculation checks. These utilisations may be presented as a design envelope (see Figure to right), where engineering judgement is required to definitively state which columns require remedial work.

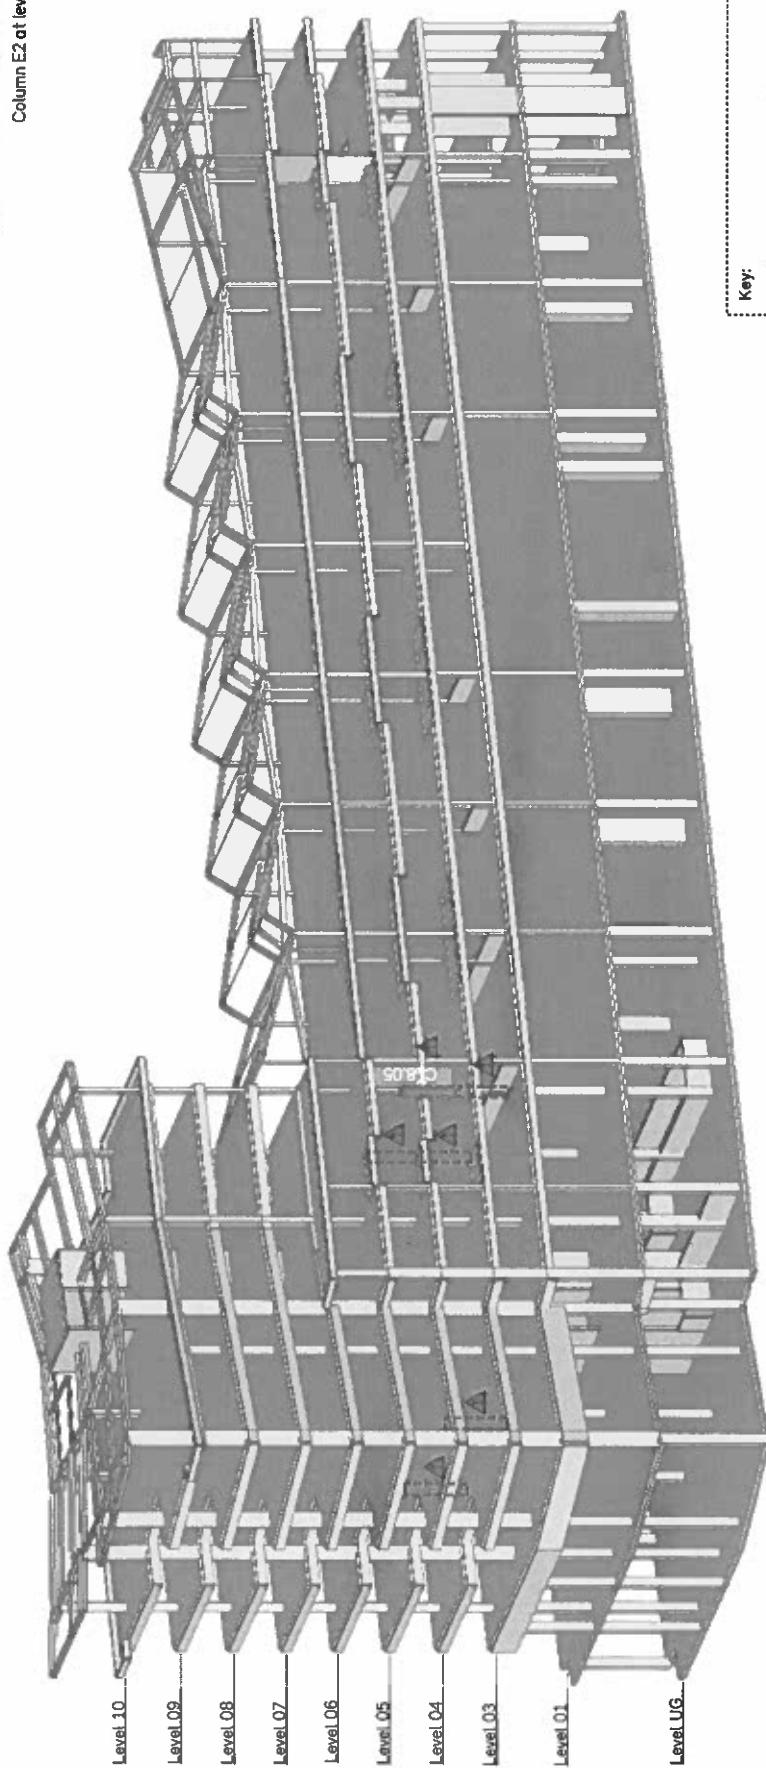
Column E2 at level 04, apartment 406

Column E2 at level 04 (C18.05), dimensions 215 x 610 mm, has been highlighted in the below image from our finite element analysis model. This is the column that has partially failed and been propped in the interim.

The adjacent photograph shows column E2 at level 04 (C18.05) prior to prop installation. It is believed that column E2 partially failed due to apparent repair work with a non structural repair product, this should be confirmed by testing by others.

From site measurements we can see that the column cross section is greatly reduced in the middle third of the column, to approximately half or less of the intended cross section. The effect of reducing the width of the section of structural concrete was studied and it was estimated that that column would begin to fail, under serviceability loading, when the concrete section reduces to approximately 165 x 610 mm, with original arrangement of reinforcement.

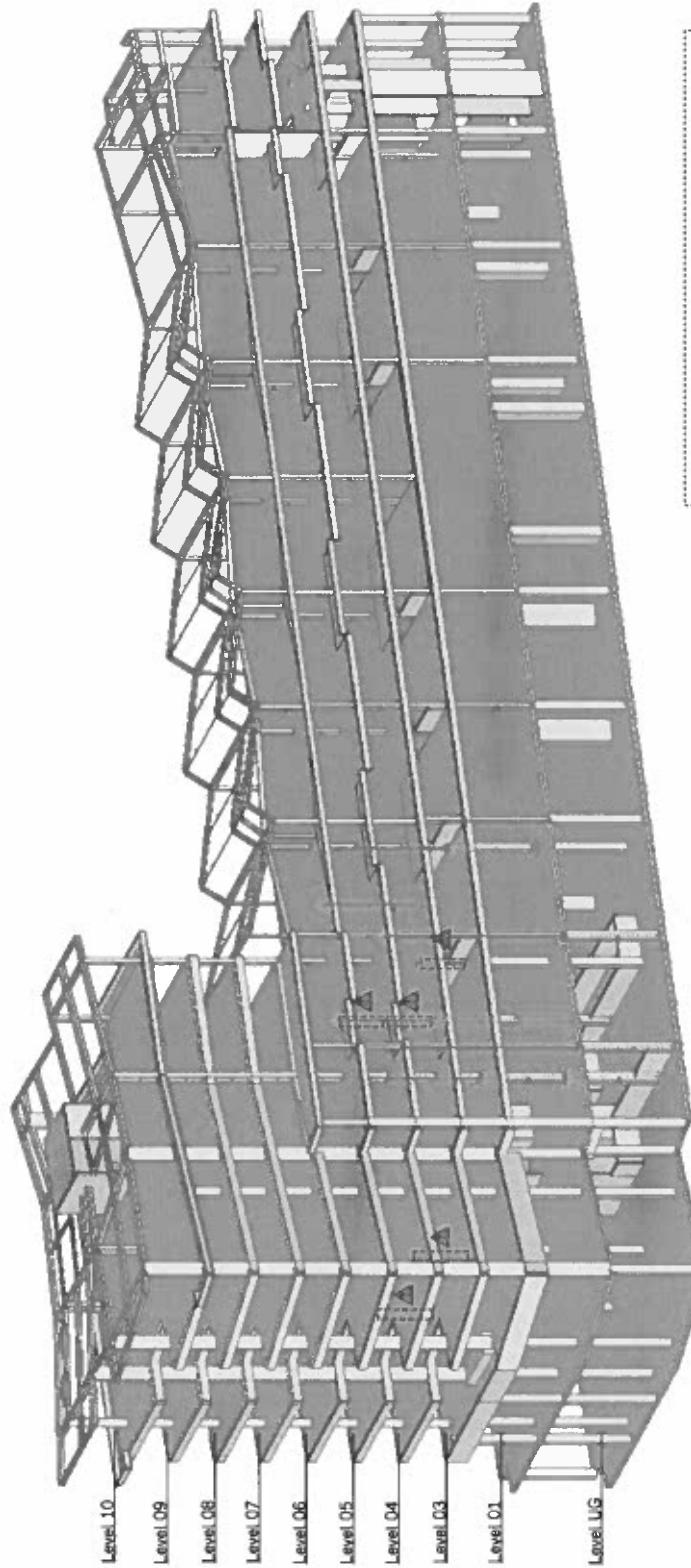
Load Redistribution		Column	% Increase in Axial load from design load
C04.02	4.7%		
C04.03	5.1%		
C04.04	4.7%		
C05.02	42.7%		
C05.03	52.5%		
C05.04	102.1%		
C05.05	168.7%		
C06.03	2.5%		
C17.02	13.0%		
C17.03	15.7%		
C17.04	19.2%		
C17.05	24.1%		
C19.03	11.6%		
C19.04	16.9%		
C19.05	27.4%		
C29.02	11.6%		
C29.03	14.8%		
C29.04	21.0%		
C29.05	27.0%		
C30.04	1.3%		
C30.05	1.6%

3D model showing highlighted columns in apartment demise affected by redistribution

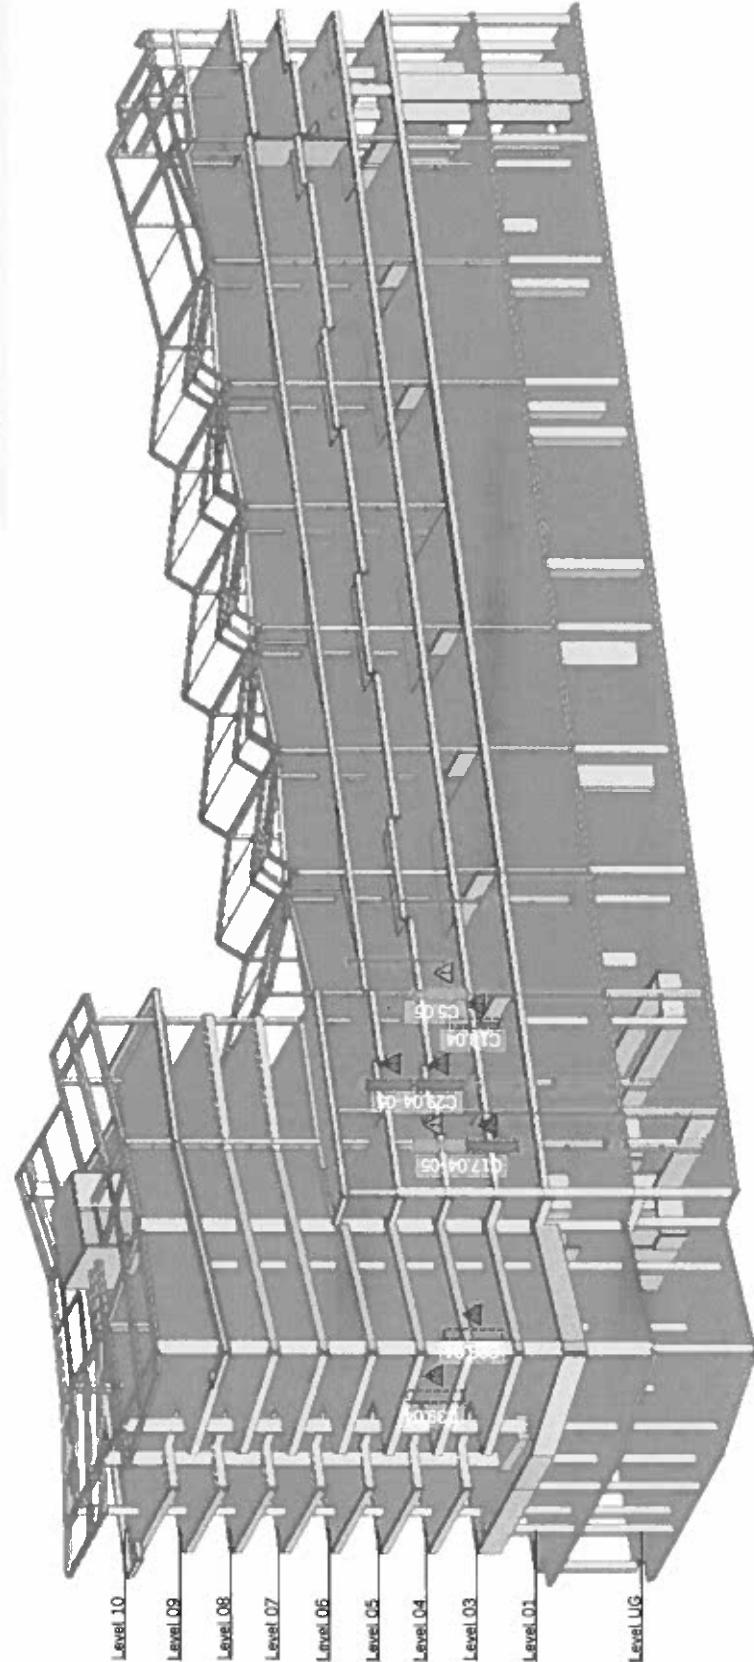
*It should be noted that 2 sections were already above 100% utilisation, according to in-house calculations, before the partial failure of column E2 at level 04 (C18.05). The additional load due to the redistribution has increased the utilisation further and these columns are now at higher risk due to the redistribution. Of which, columns C29.04 and C29.05 previously being identified as 'critical'.

3D model showing highlighted columns in apartment demise exceeding design capacity due to redistribution.			
Key:			
Previously Identified as Critical			
Columns Affected by Load Redistribution			
Columns Identified for Further Consideration Upon Load Redistribution			
Columns Identified as Critical Upon Load Redistribution

As previously advised under the original design load utilisation review, these 5 no. sections should be strengthened. The strengthening works will be designed for the redistributed forces where applicable.

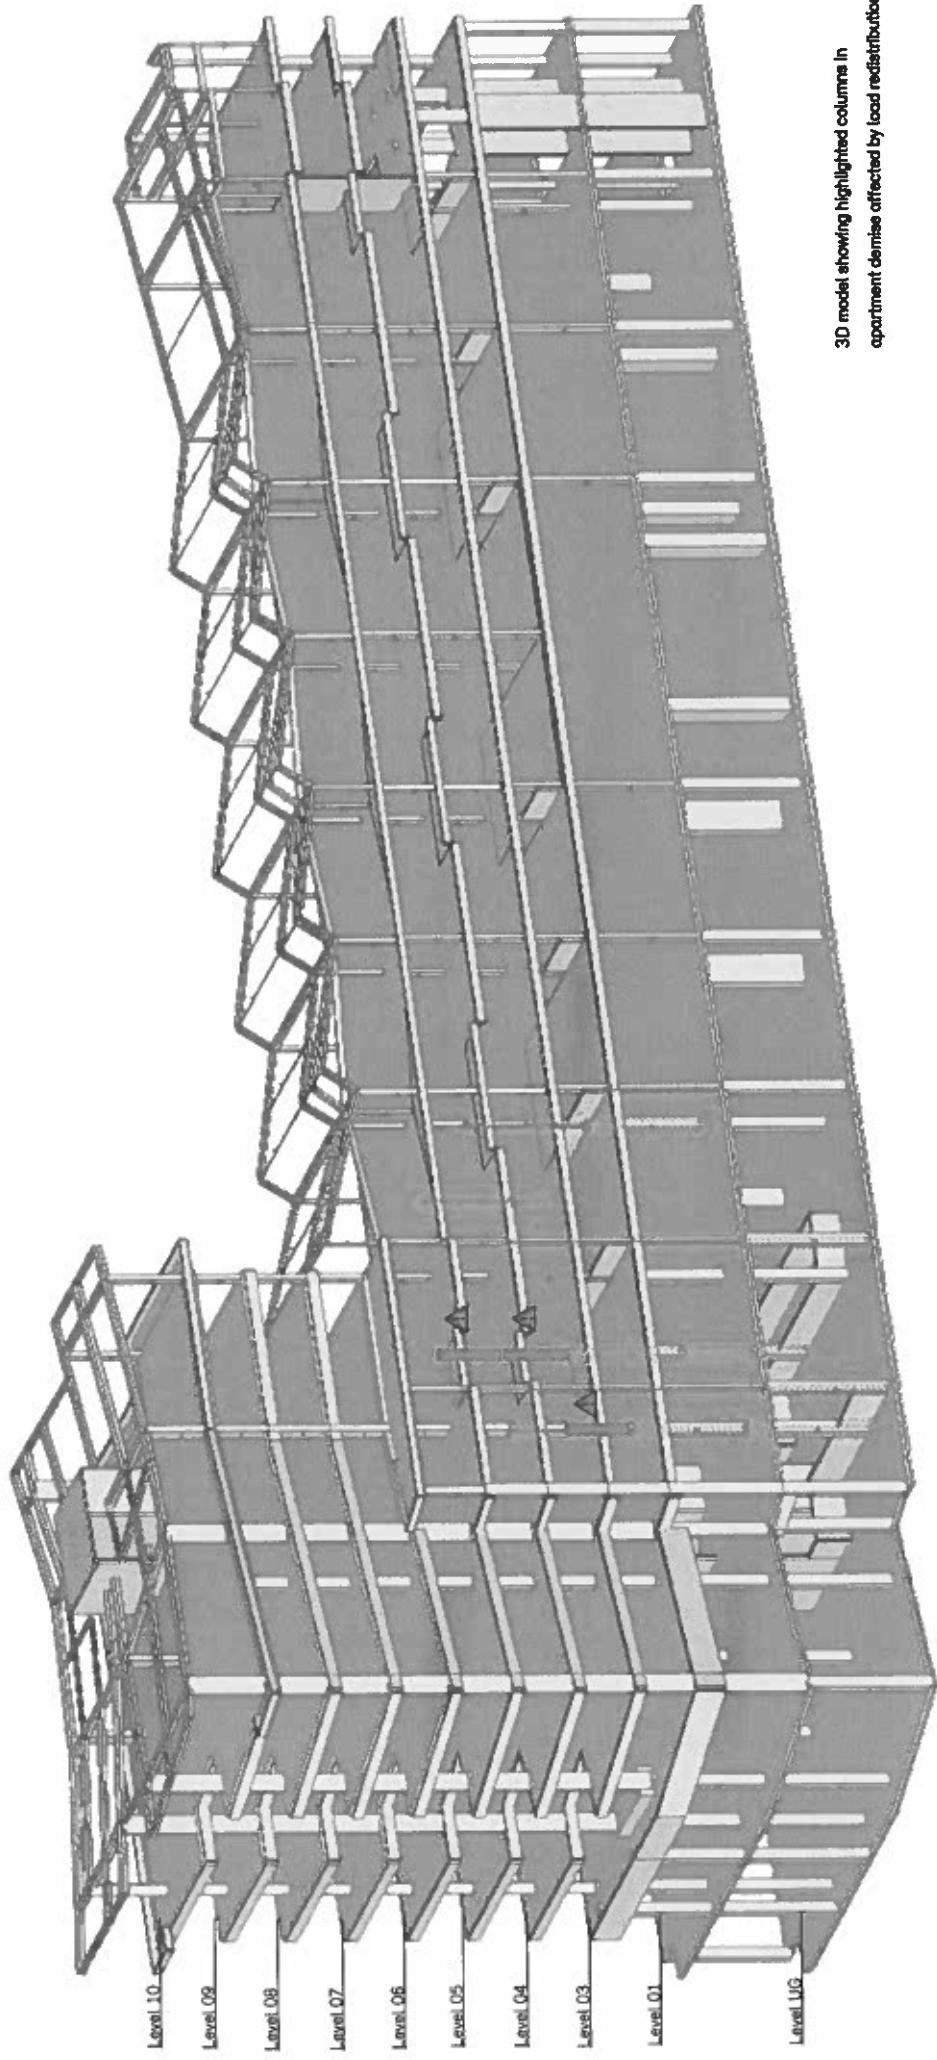
3D model showing highlighted columns in apartment demise affected by load redistribution

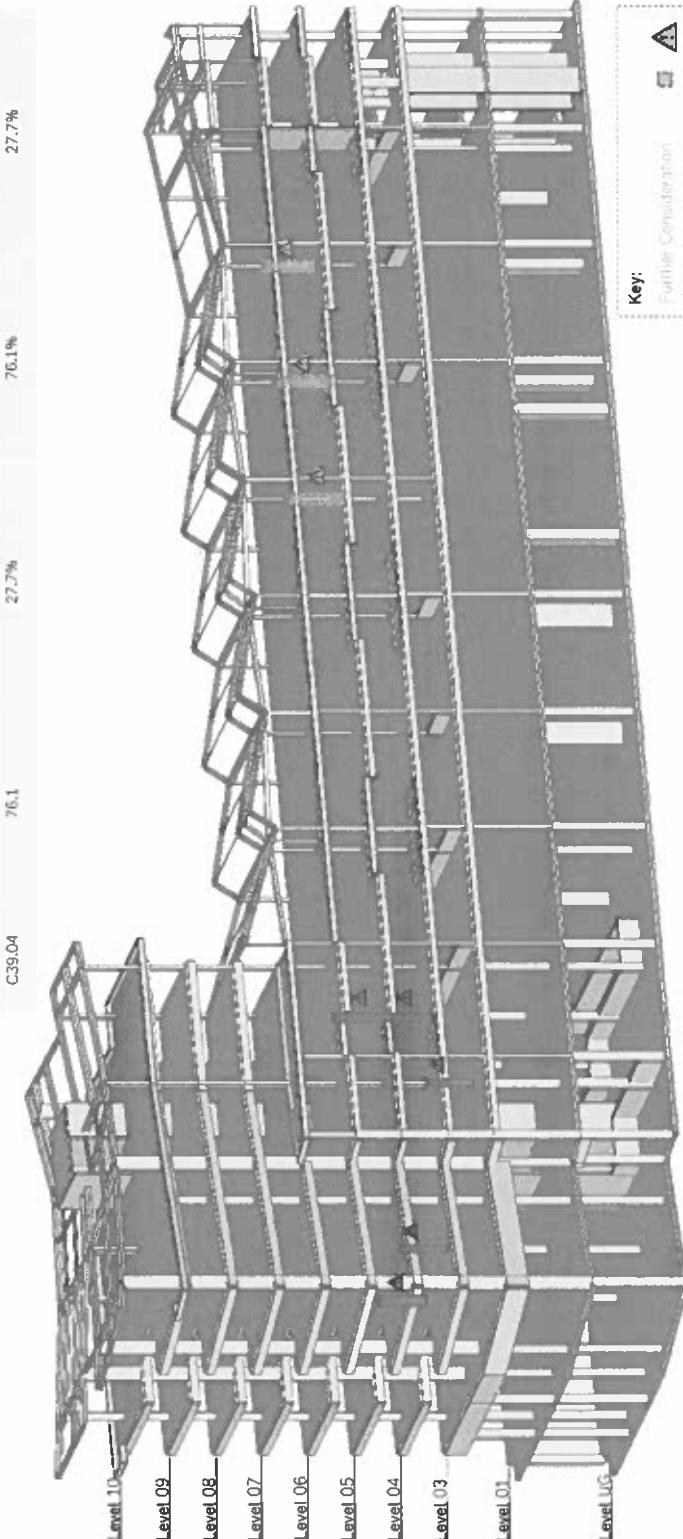
The risk of potential further failures based on column capacities has been summarised in the adjacent table showing current status and shown in the 3D image below.

Currently 5 no. columns are over capacity. It should be noted that 4 of these columns were over capacity prior to the load redistribution. The load redistribution has pushed 2 of these columns further over capacity.

Column C18.05 under the accidental load combination is also within capacity, therefore further confirmation that the failure may have occurred due to the construction defect. It is imperative that this list of 8 columns are checked for construction defects.

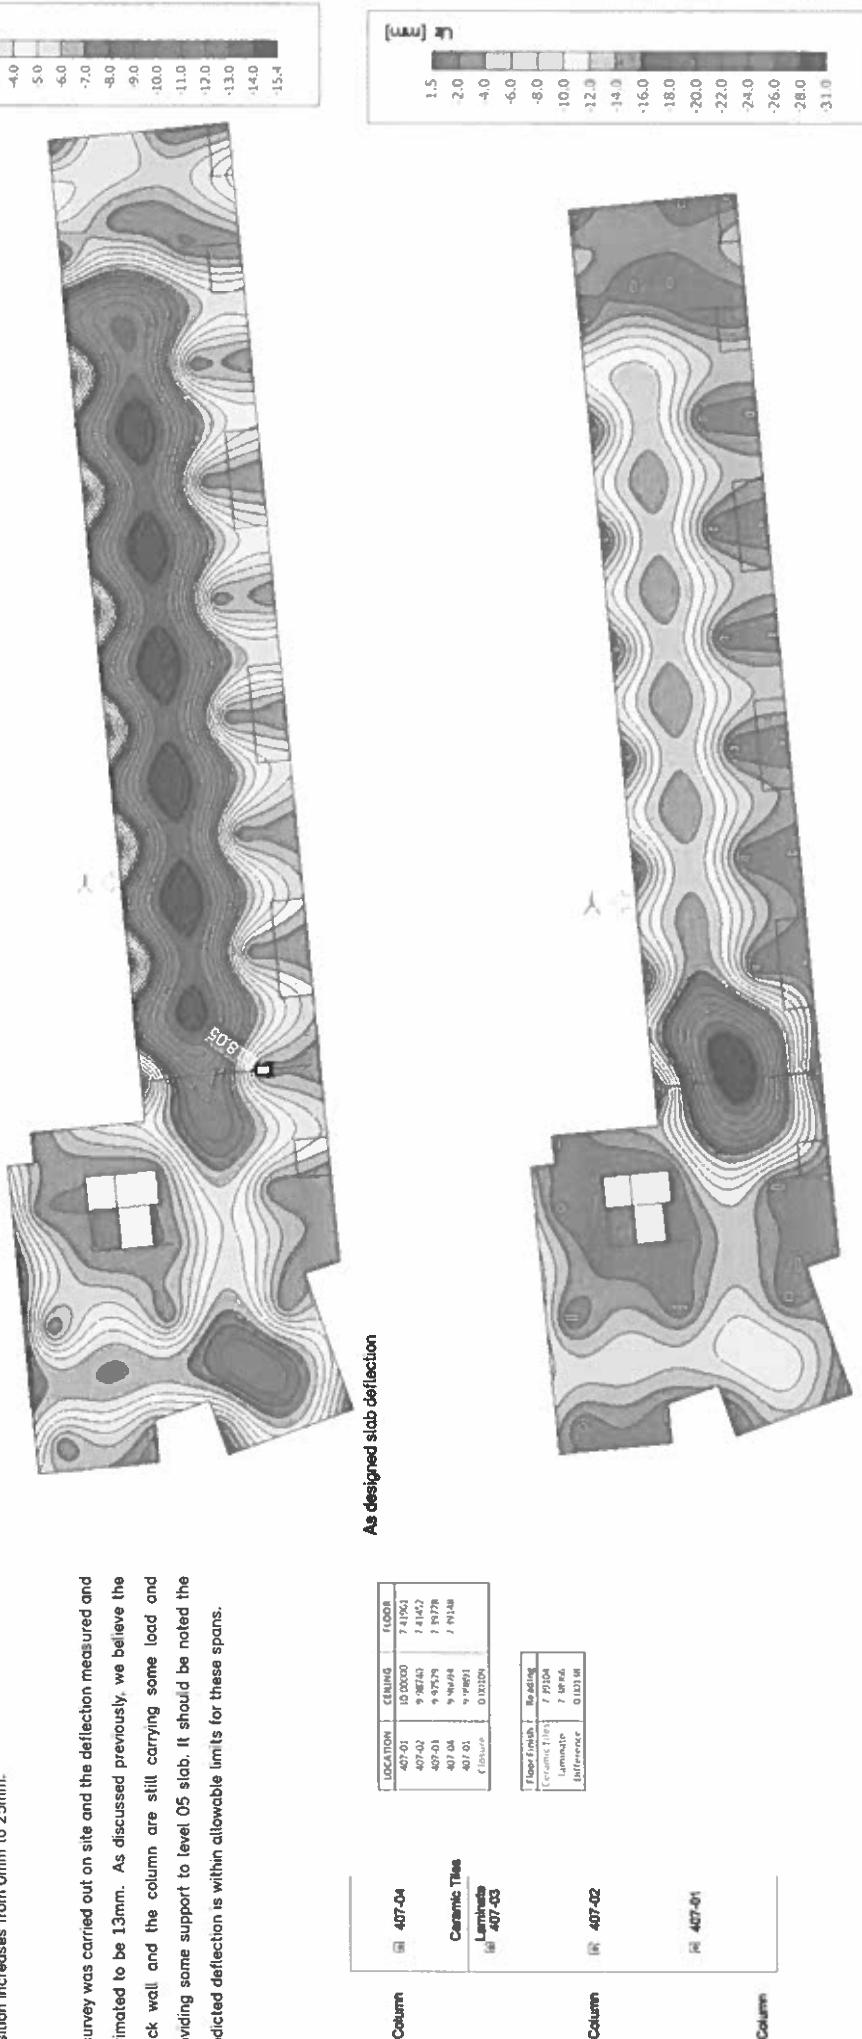
Survey extract by Scudin for McFarland Associates March 2019

As column E2 at level 04 (C18-05) is designed to directly support the level 05 slab, the partial failure of the column will have increased the deflection in the level 05 slab. The first image shows the predicted slab deflection¹⁰ for the original design.

Slab deflection assuming column E2 at level 04 is removed entirely
