## REPORT TO THE COMMISSIONER OF VALUATION

Apartment 309  
70 Chichester Street  
Belfast  
BT1 4JQ

Apartment (3<sup>rd</sup> floor)

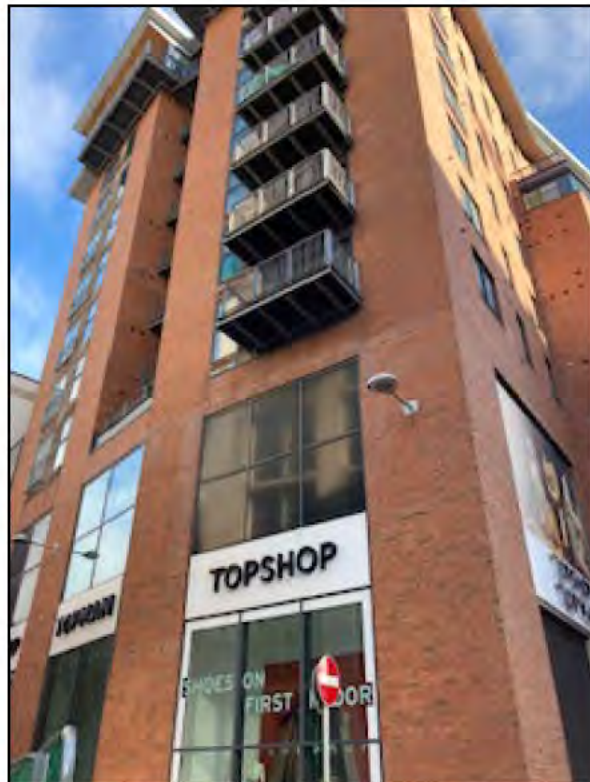
**Side elevation of subject**

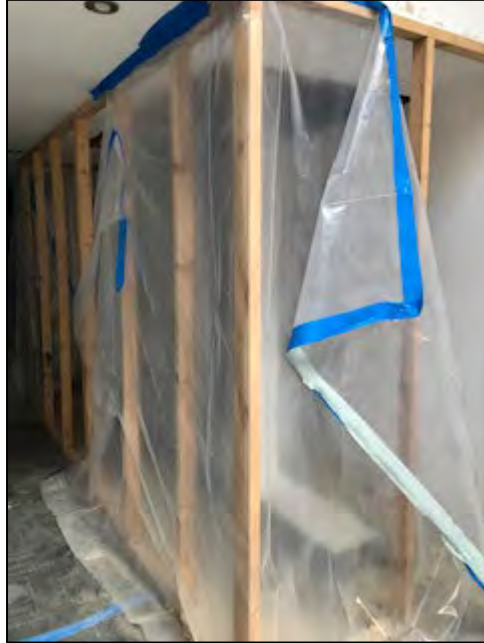
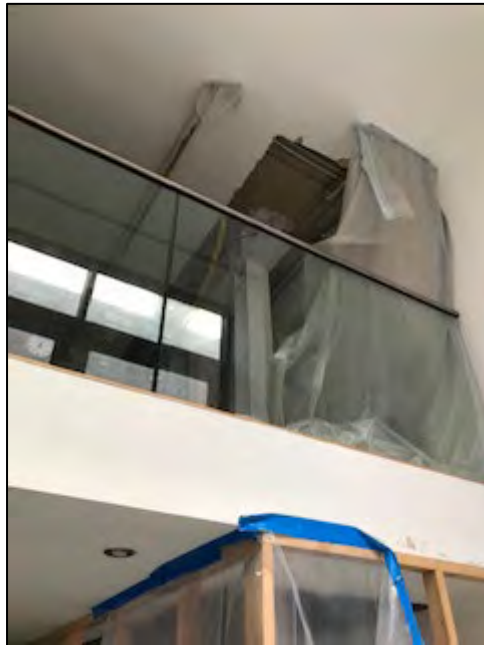
**Apartment 202 (PID 960554)**

**Multi-Level Self Contained 1<sup>st</sup> & 2<sup>nd</sup> floor apartment:  
Inspected 28/9/21**

We first inspected the 1<sup>st</sup> & 2<sup>nd</sup> floor multi-level apartment 202. As illustrated in the photographs on pages 10-12 I could see the props (steel support columns) that have been installed either side of the failed steel column. These props have 'strain sensors' attached, which are measuring the load the 'props' are taking. The data recorded by the sensors is being monitored remotely. The solicitor advises that the apartments that these are in (approx. 17) cannot be occupied as the vibration would be picked up by the 'strain sensors' resulting in inaccurate readings.

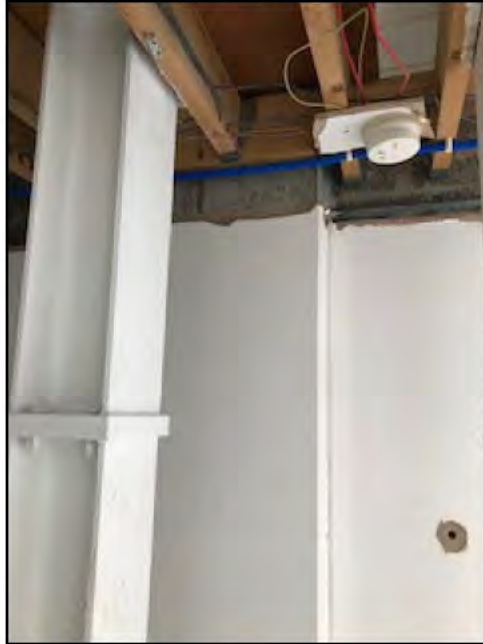
**Props & failed steel column**

The appeal is in connection to partial failure of column E2 in apartments 406 & 407 on the fourth floor of the apartment development. Temporary props (steel columns) were installed in 2019 to support the defective column until repairs could be carried out. This propping has been carried out down to basement level.

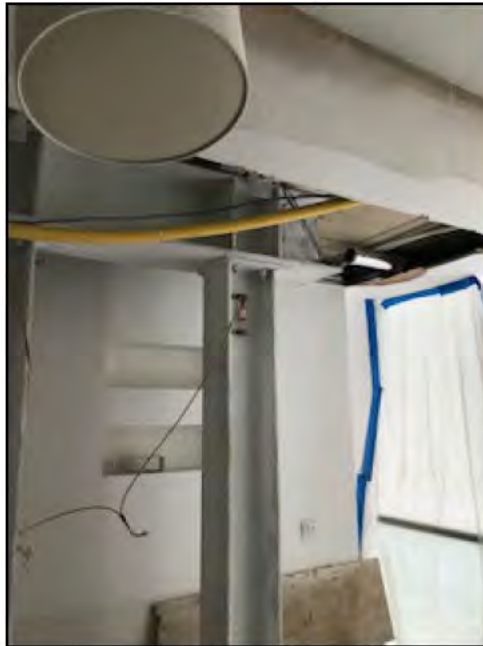
**Strain sensors: attached to props (steel support columns)**

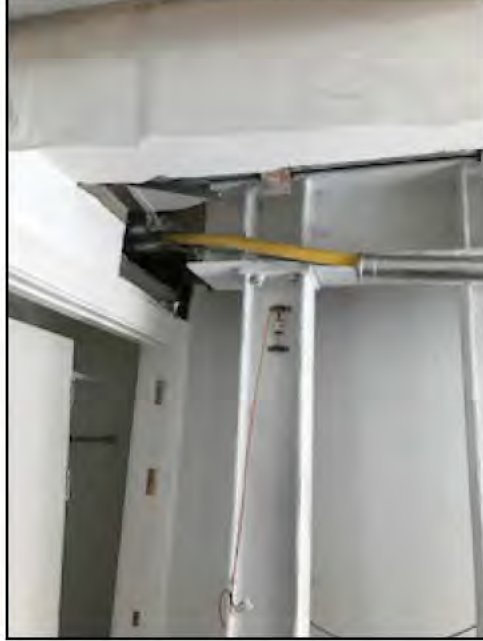
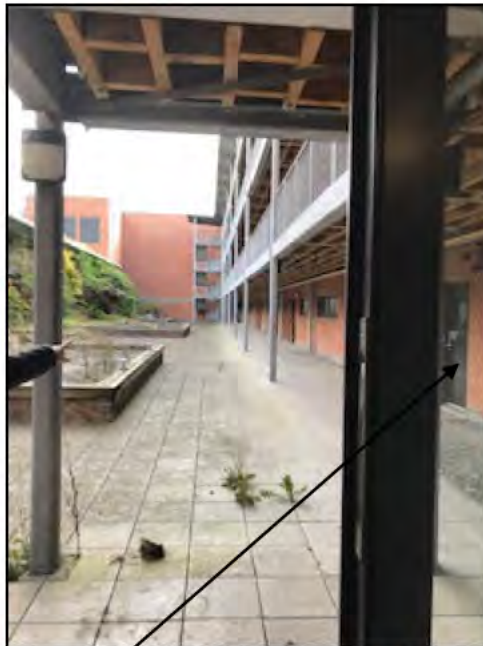
**Apartment 307 (PID 956713)**

**Single-Level Self Contained 3<sup>rd</sup> floor apartment:  
Inspected 28/09/21**

**Location of Apartment 307**

Apartment 306 was not available to view. We viewed apartment 307. Minor distress can be seen in the adjacent photographs - cracking in the plasterwork at column E2. Further cracks were noted where the dividing blockwork wall meets column E2 and along the line of the ceiling and the dividing wall. We would assume these cracks have appeared due to movement caused by the partial failure of the column of level 04.

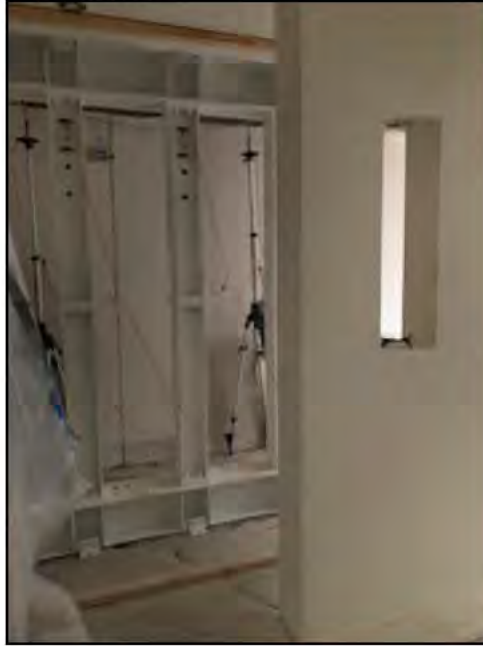
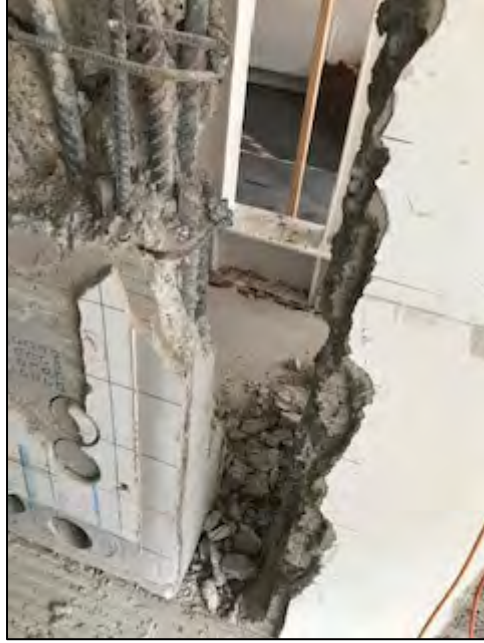
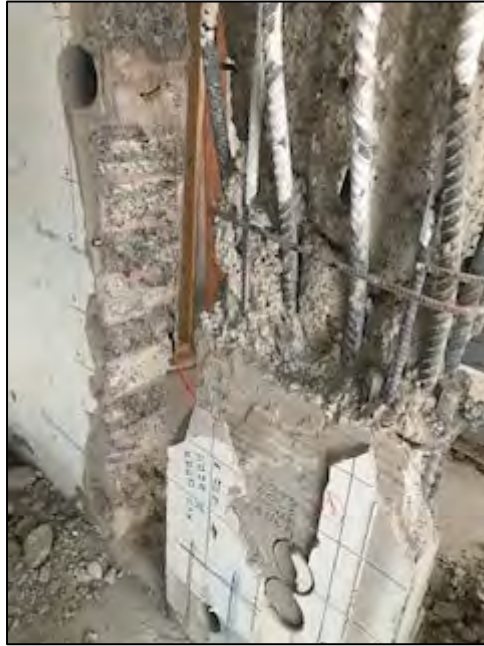
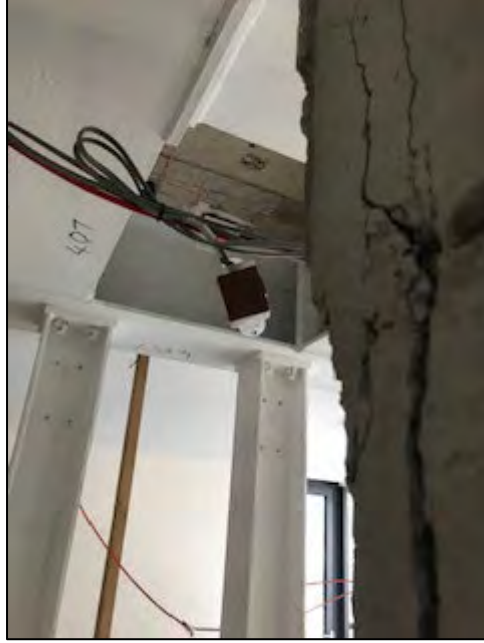
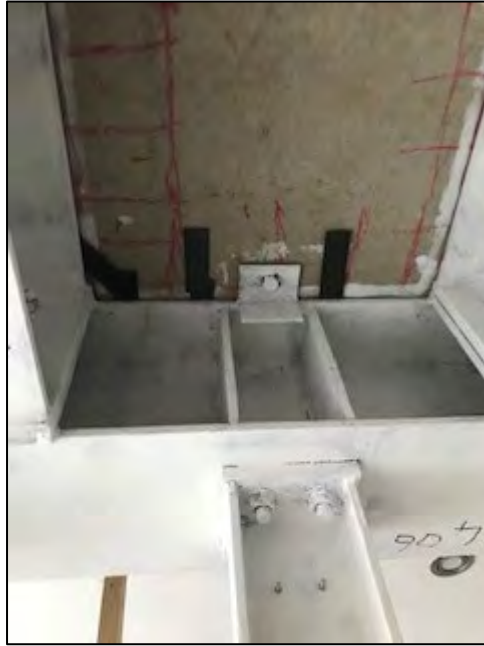
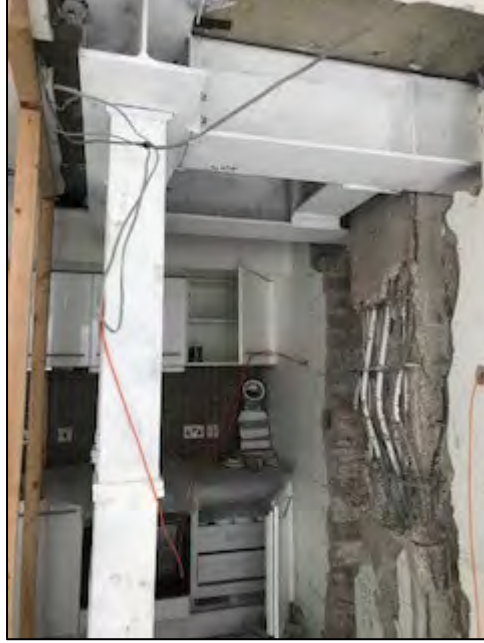
**Apartment 406 (PID 960576)**  
**Single Level Self Contained 4<sup>th</sup> floor apartment:**  
**Inspected 28/09/21**

The nature of the damage was more evident in Apartment 406. The exposed reinforced bars were clearly bulging out of the partially failed E2 structural column (see report pages 14-19 above for photographs).

We can see the reinforcement bars within the column have bulged and deformed, by approximately 80mm laterally. There is material loss where the bars have displaced. The reinforcement bars have been painted white at some stage. It is clear that a repair has taken place on the column, we would assume prior to fit-out stage. The repair material is pink in colour, and does not appear to be a concrete repair product - this should be confirmed by sampling.

The bottom row of photographs show the damage in apartment 407. There appeared to be less damage evident on this side of the column. There were no obvious signs of repair to this side of the column.

We can reasonably assume the reinforced concrete column has partially failed at this level due to the historic repair work.

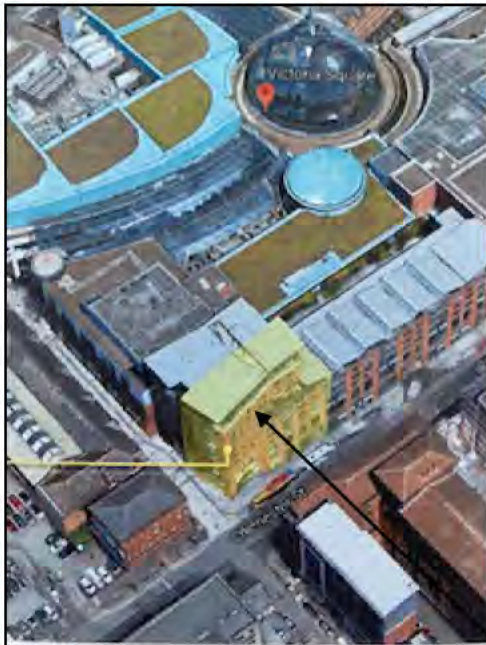
This report details a structural assessment of a column within the subject apartment development, which was described as displaying signs of distress. The scope of the report was to carry out a baseline condition survey, report on the current state of the existing structure, assess the existing structure and advise on immediate and long term remedial actions.

**Extract from report – the affected block**

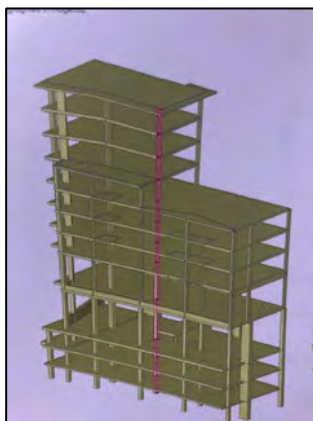
**3D model with defective column E2 in red:**

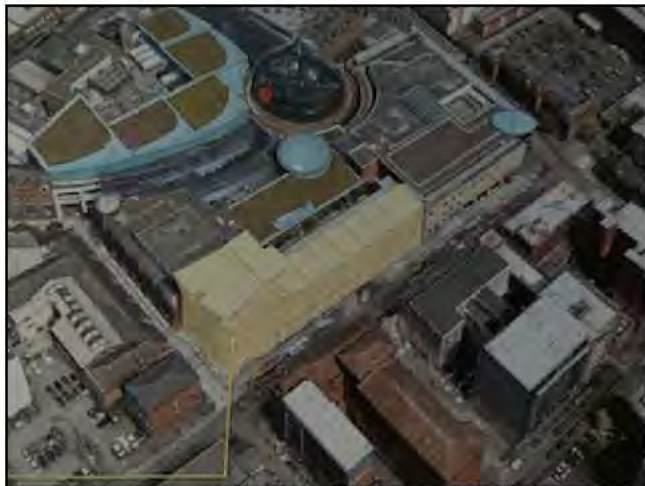
This was carried out following a partial failure of a column within the subject apartment development. The report was commissioned to carry out a full structural review of the apartment building, reviewing original design and identifying any areas where the columns or slabs are highly utilised and have the potential to be high risk where a repair might have been carried out, also to establish the structure which could have been impacted by the failure by way of load distribution and finally advise on the risk of potential further failures.

**Extract from report – affected apartment block**

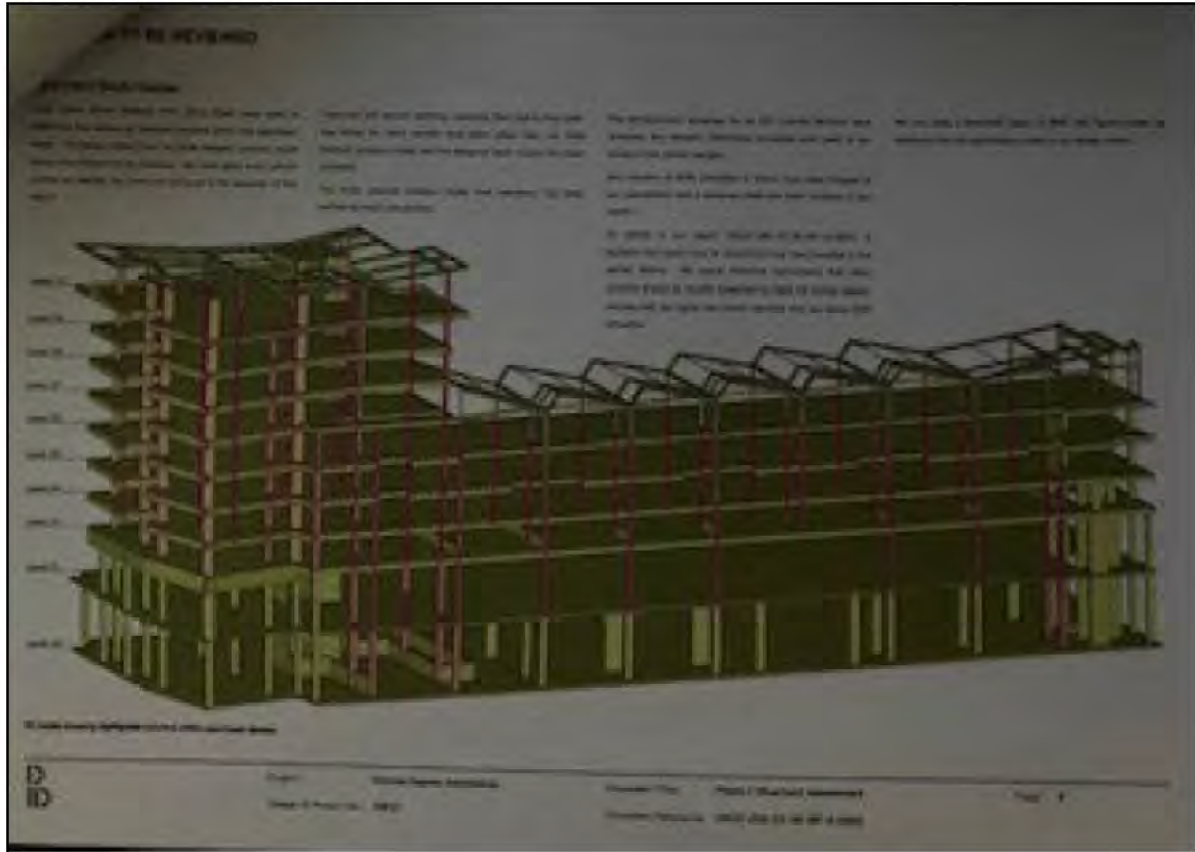
3D model showing the highlighted columns, which are above 95% utilisation under the original design load:

The report states that it is believed that column E2 partially failed due to apparent repair work with a non-structural product.

Currently 5 no. columns are over capacity. It should be noted that 4 of these columns were over capacity prior to the load redistribution. The load redistribution has pushed 2 of these columns further over capacity.

The accidental load combination check shows that the risk of these columns failing is not as severe as the standard ultimate limit state review may suggest. Particular attention should be paid to column C29.05 which even under the accidental load combination is exceeding capacity. To reduce the risk of a failure, C29.05 should be propped or strengthened immediately.

All 8 columns must be reviewed immediately for construction defects as these would lead to further failures.

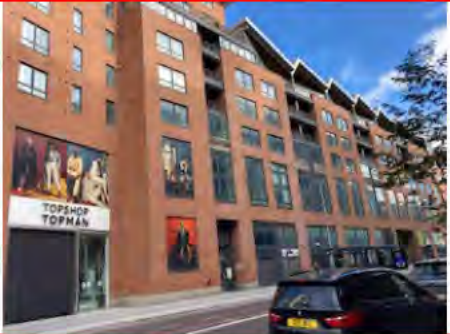
960567	Apartment 301, 70 Chichester Street	Privately Built Housing Purpose Built Apartment  Single Level Self Contained  Hab space 64 m2	£140,000	C	Central
